SUSAN JACOB BEng. MSc

**UNIVERSITY OF ABERDEEN
DISSERTATION SUMMARY PRESENTATION**

**AN INVESTIGATION INTO THE
WRINKLING PHENOMENON ON CRA
LINED PIPELINES AND ITS IMPACT ON
PIPELINE INTEGRITY**

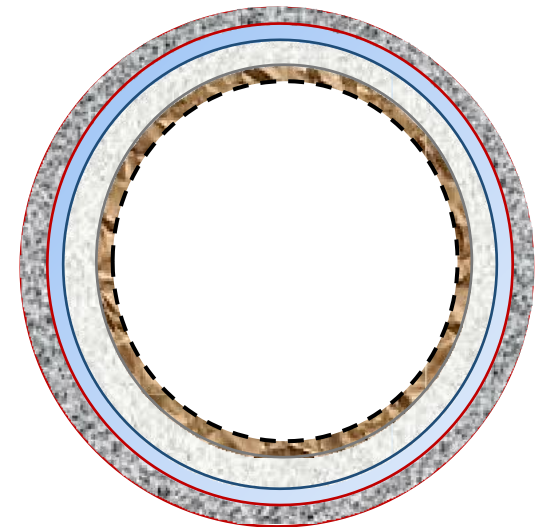
- PL2 is a 16" / 18" Pipe-in-Pipe pipeline transporting hydrocarbons from Bravo to Alpha
- **PL2 was a replacement for PL1 in 2008 due to:**
 - Under scale corrosion
 - Low remaining wall thickness
- Lessons learned implemented
 - 3mm CRA liner
 - Rigorous scale removal tools
 - Monitoring of scale build up with pigging tool runs
- **Baseline intelligent pig in 2008 of PL2** identified potential wrinkling of the liner, noted in subsequent caliper pig runs

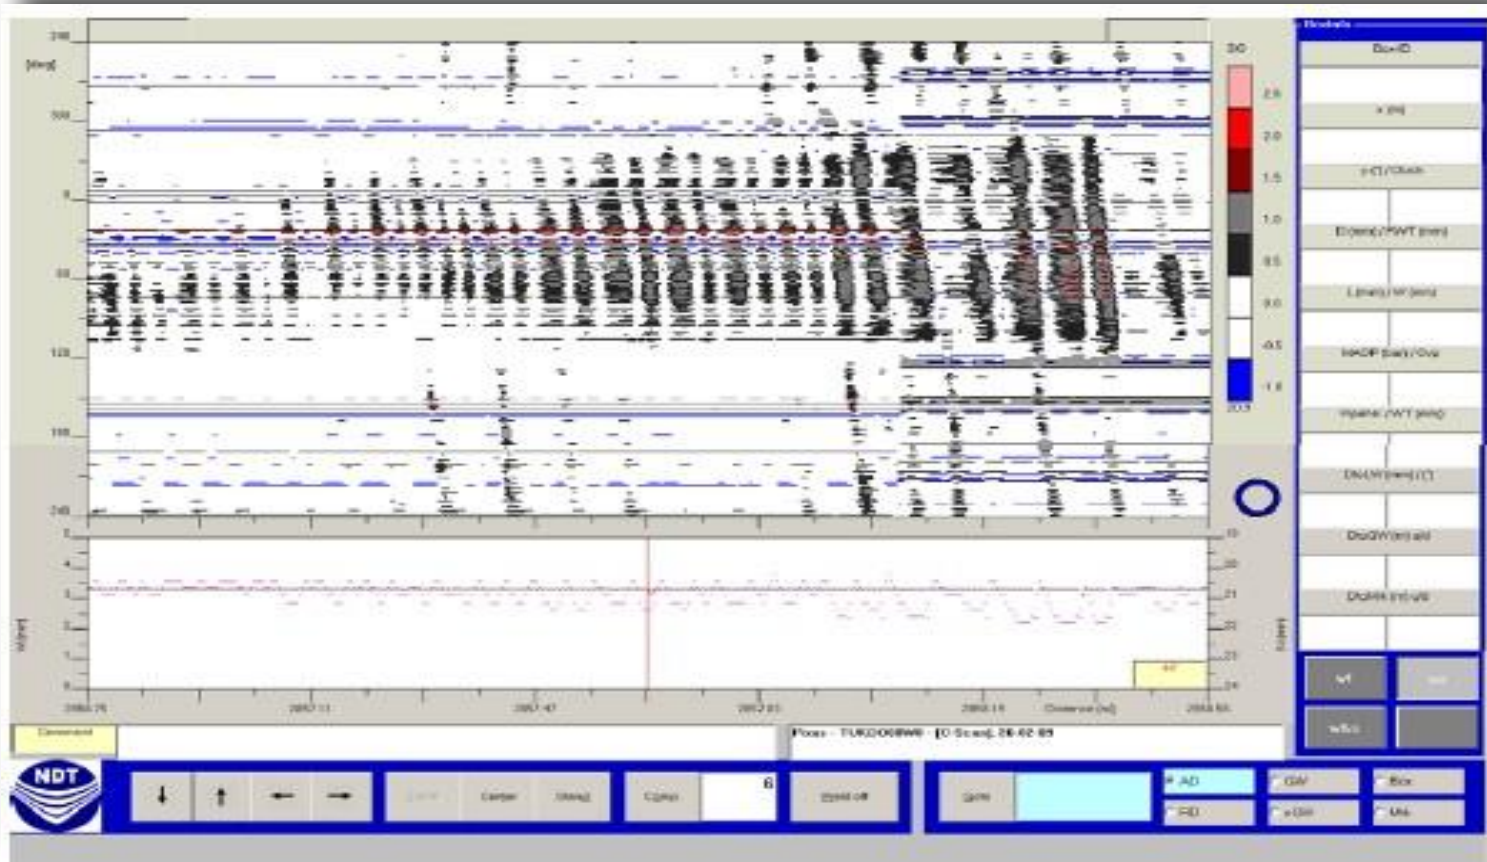
Sample of Baseline inspection from the intelligent pig run carried out post installation

- **Baseline intelligent pig run in 2008 identified potential wrinkles**
- Wrinkles appear to match up with Stage 3 & 4 deformations determined by Yuan & Kyriakides
 - Not yet Stage 6 and 2nd bifurcation

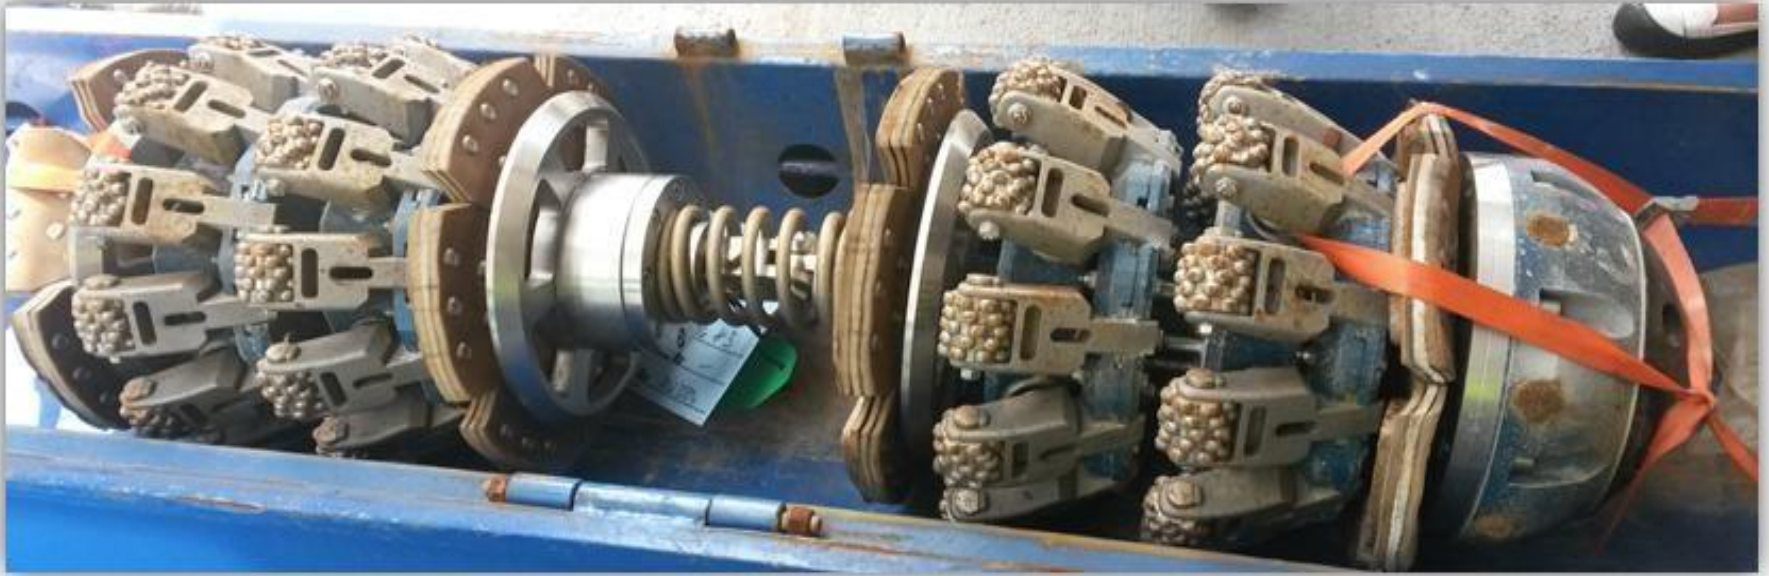
- Aggressive scale removal tools remove the wrinkles **exposing** areas of carbon steel to corrosive fluids.

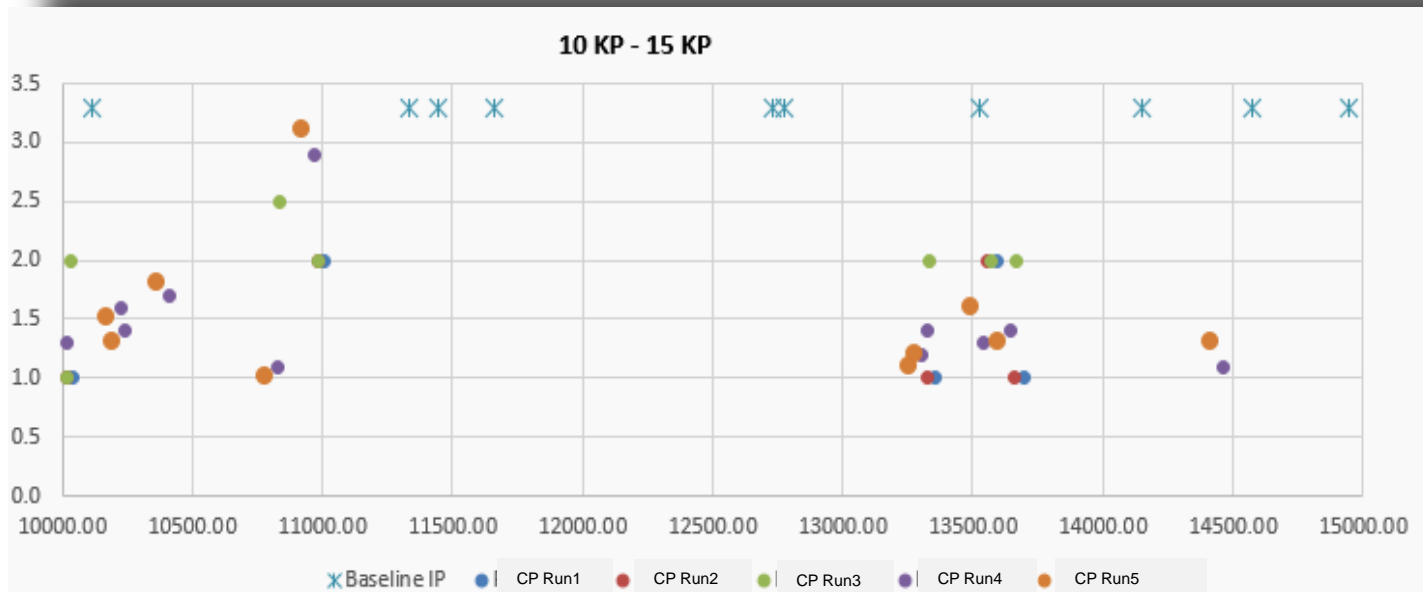
- Main objectives of this study is the comparison between the IP results and the 5 caliper pigging tool (CPT) runs over the 9 years of PL2 operation
- **An example shown below**, shows that the IP and caliper pigging tools are different and they record different sets of data.
- Although some areas have been noted to coincide showing wrinkles formed post installation have not progressed to secondary bifurcation
