# Failure Analysis – An Insight Into Forensic Investigation, Failure Mechanisms & Prevention

26<sup>th</sup> November 2024

Sarah Bagnall

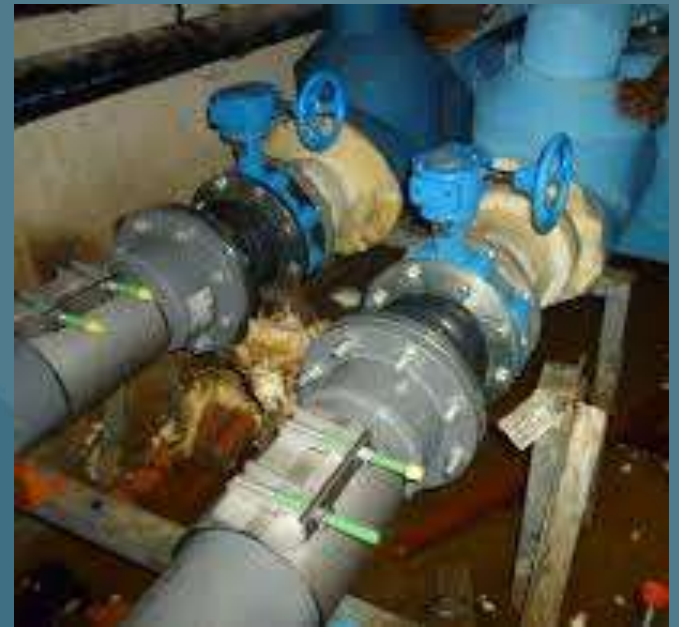
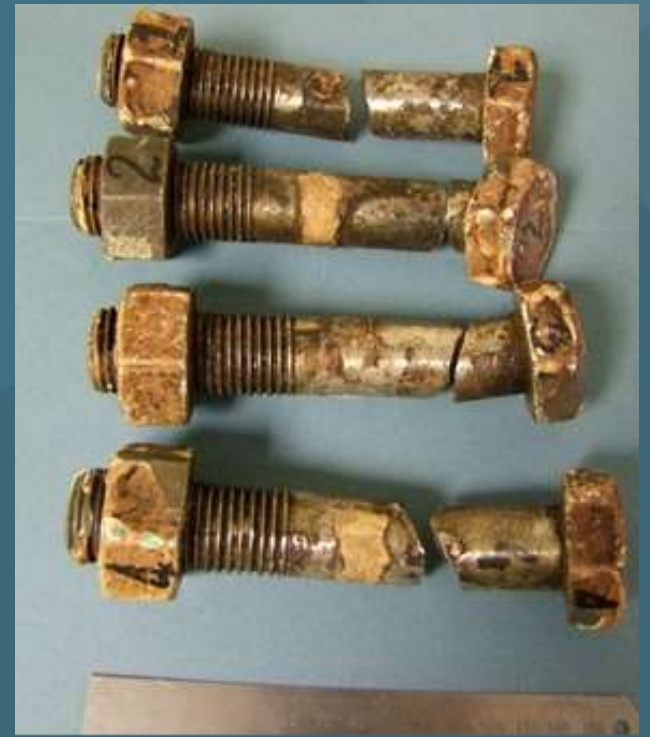
- Client experienced an oil leak from the main cargo line of an oil tanker used to transfer gas oil, gasoline, diesel and oil.
- The bolts used to secure the flange had fractured. The bolts had been in service for 6 months
- 304 stainless steel

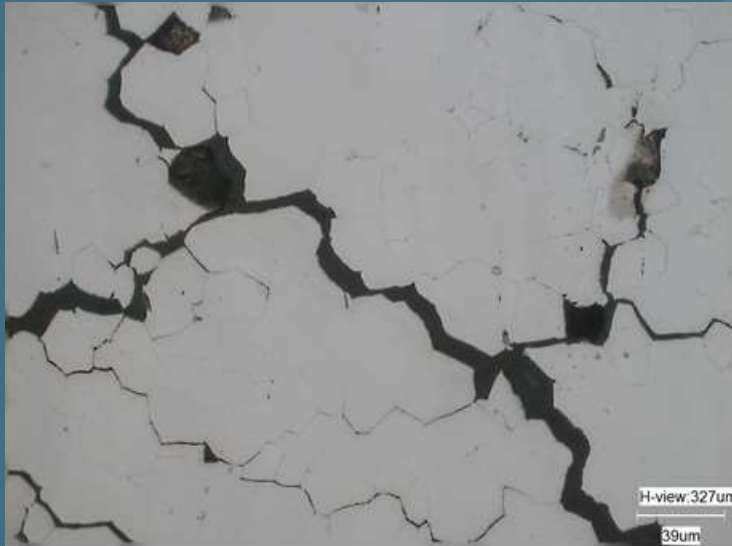
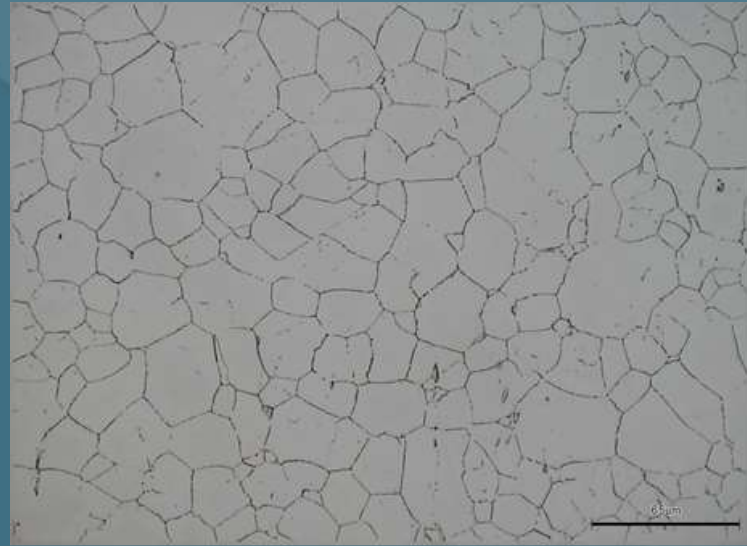
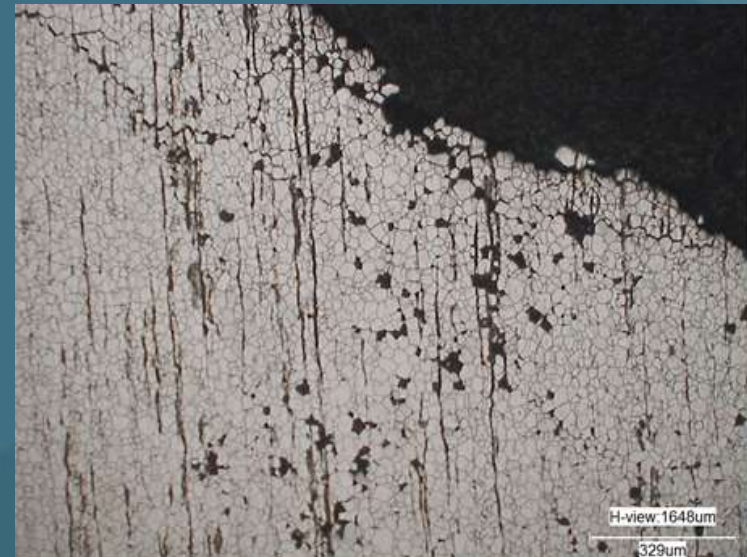
- Deposit contained significant levels of chlorine and sulphur.
- Microstructure was heavily sensitised

Mechanism was **Polythionic Acid Stress Corrosion Cracking**.

- Occurs due to the formation of sulphide scales in the presence of sulphur compounds, which then react with air and moisture during start-up/shutdown to form sulphur acids (polythionic acid).
- Sulphide is thought to have formed due to exposure to an environment containing hydrogen sulphide.
- In the presence of a tensile stress (residual or applied), polythionic acid attacks sensitised austenitic stainless steels adjacent to the chromium depleted grain boundaries, producing intergranular cracking.

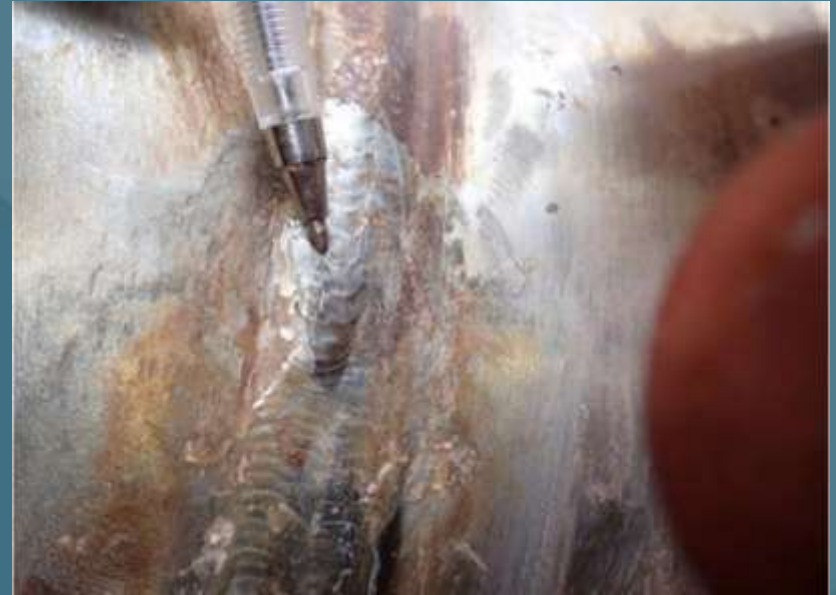
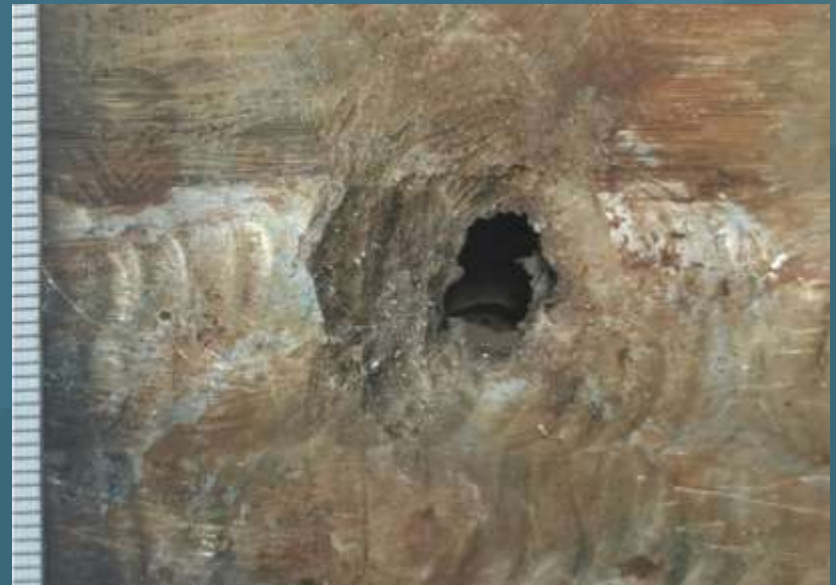
- Super duplex stainless steel pipework from a seawater injection system
- The maximum operating temperature of the outlet was 35°C.

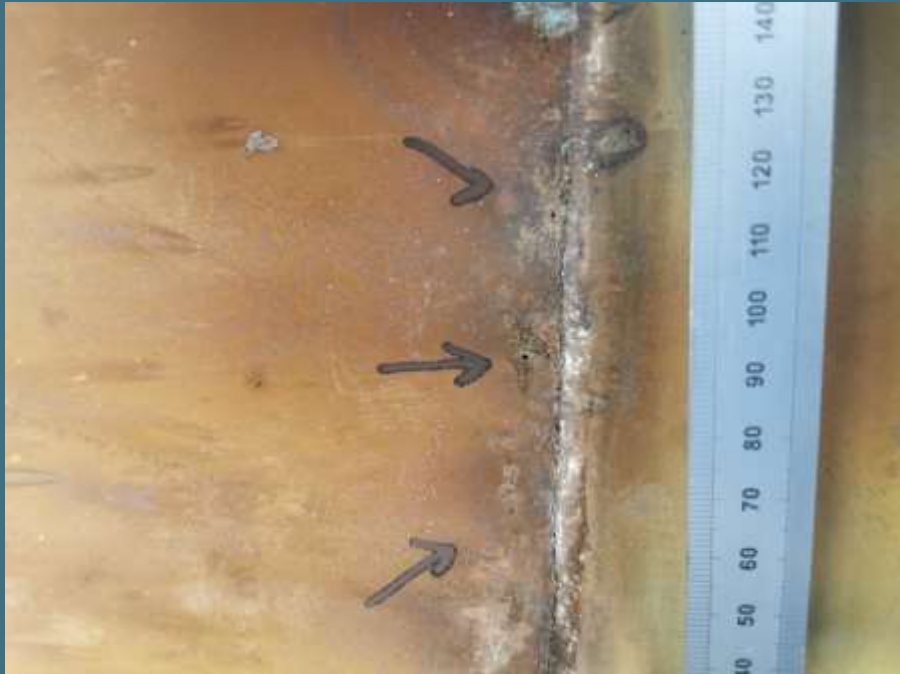
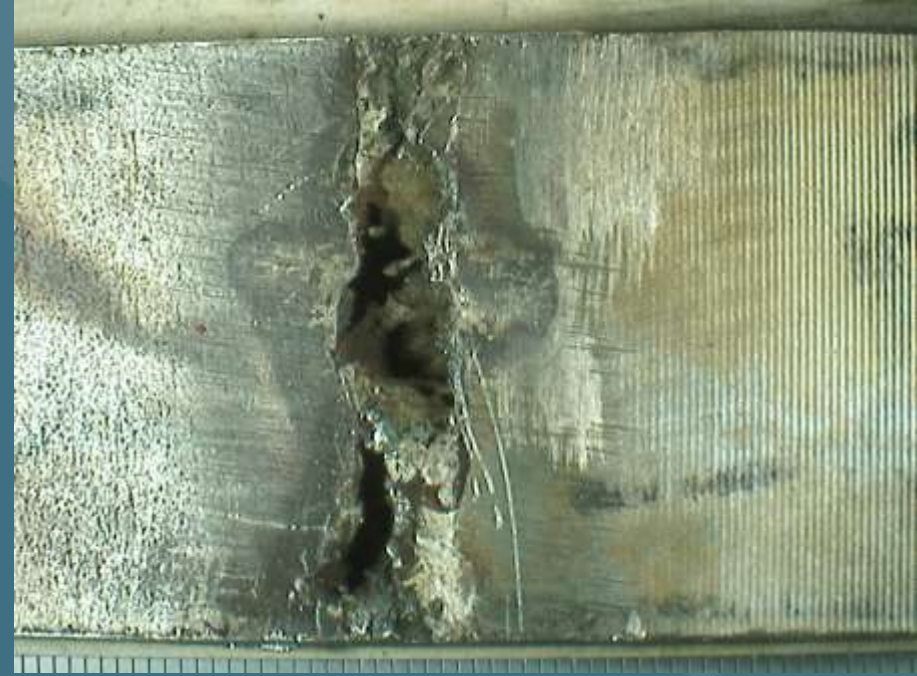
- Area of perforation evident within the weld
- At internal surface – significant metal loss was apparent below seemingly intact surface

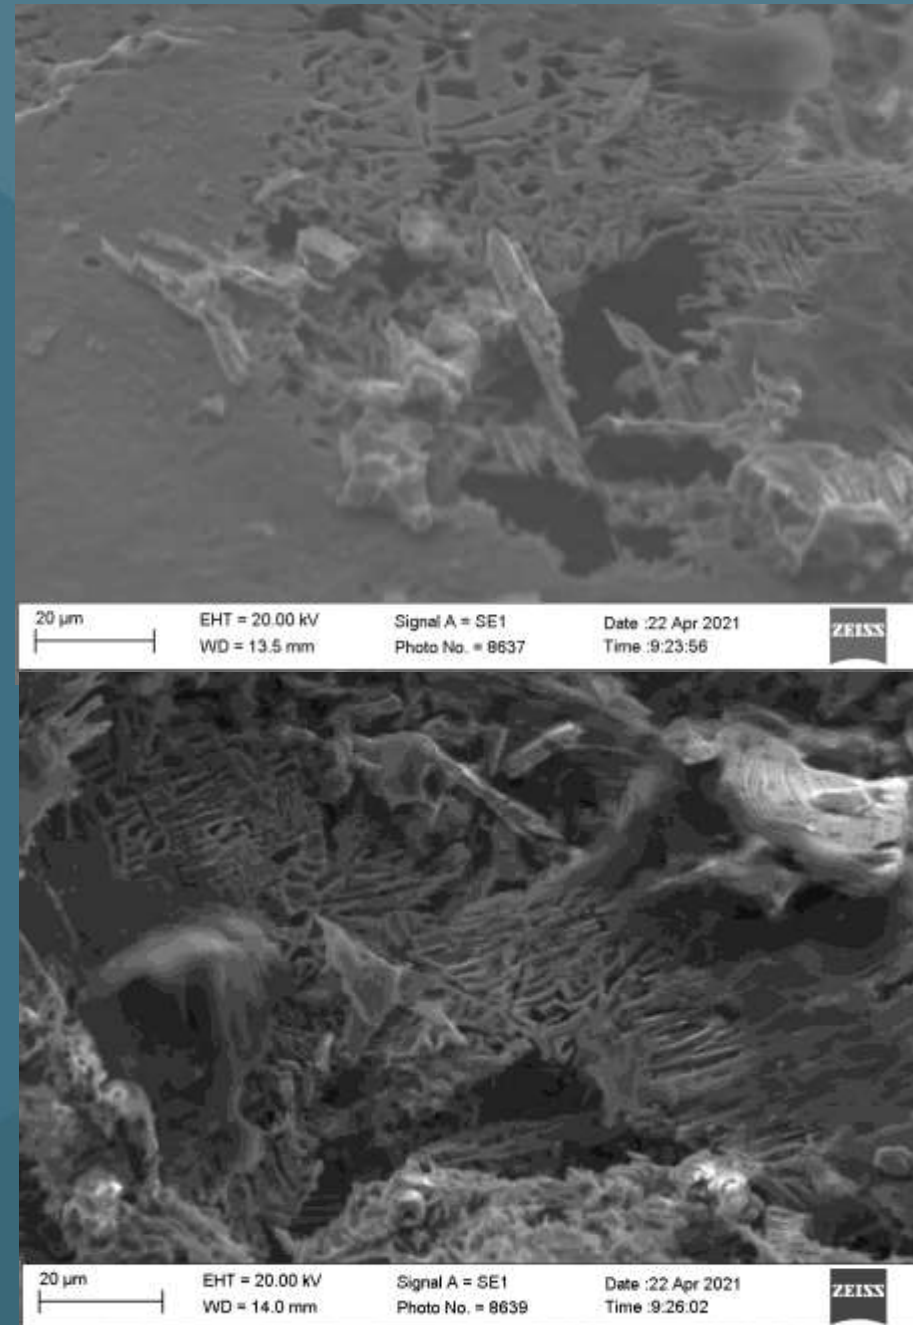
- SEM showed areas of selective attack in the vicinity of the hole
- Deposit contained significant levels of chlorine and sulphur

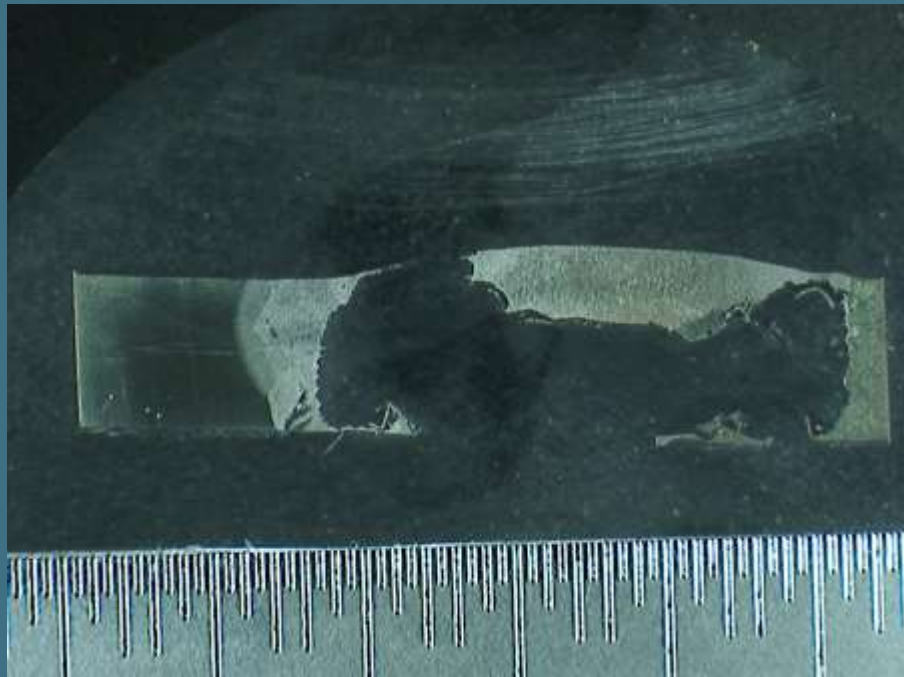
- Significant undercutting and hemispherical pitting evident within the weld metal

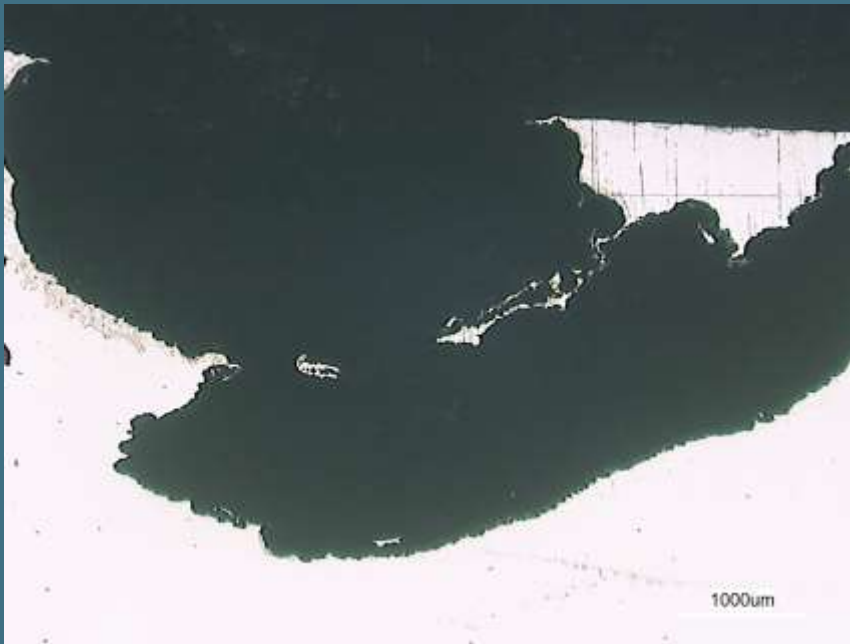
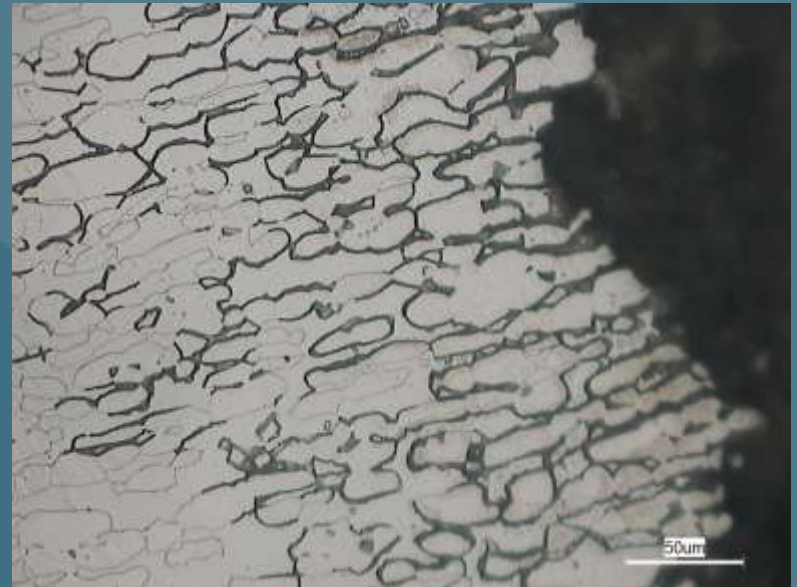
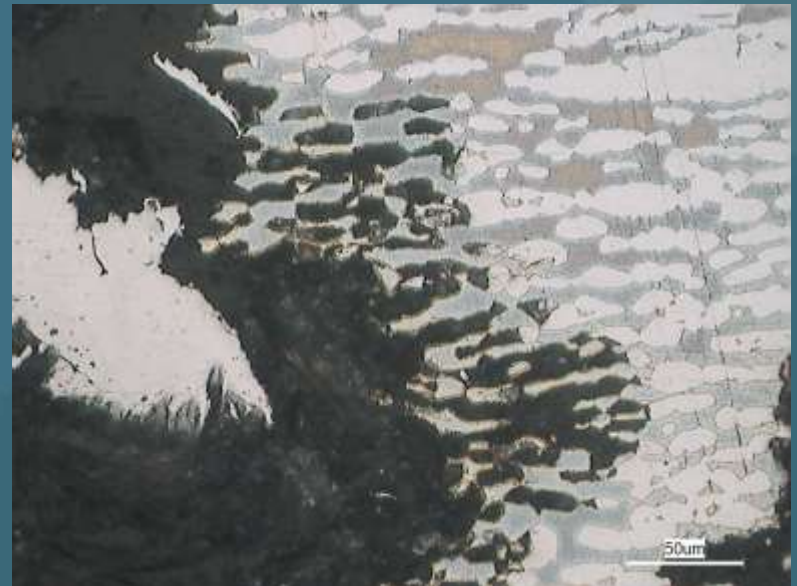
- Sigma phase & carbide was evident along the austenite/delta ferrite phase boundary
- Chemical analysis of the weld and parent materials were compliant with the specification

- Mechanism was deduced to be Microbial induced corrosion
- The presence of sulphur and the morphology of the pitting may indicate the presence of sulphate reducing bacteria. No sample was available to confirm this.
- The presence of carbides/nitrides along phase boundaries increases the likelihood of corrosion

- Water quenching after heat treatment.
  - It is important to keep the time between exiting the furnace and water quenching as short as possible.
- During welding, the heat input should be optimised so that the cooling rate will be quick enough to avoid detrimental phases, though not so fast that there remains excessive ferrite in the vicinity of the fusion line.
- To maintain operational usage of the unit as far as possible in order to ensure continued flow through the elbow.
- If downtime for long periods is expected, adequate drainage and drying is necessary

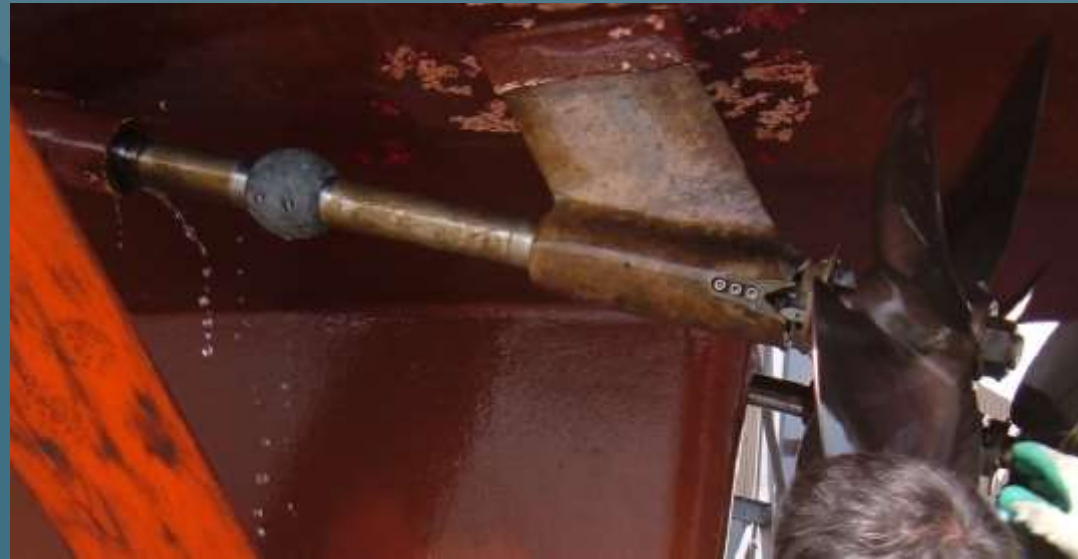
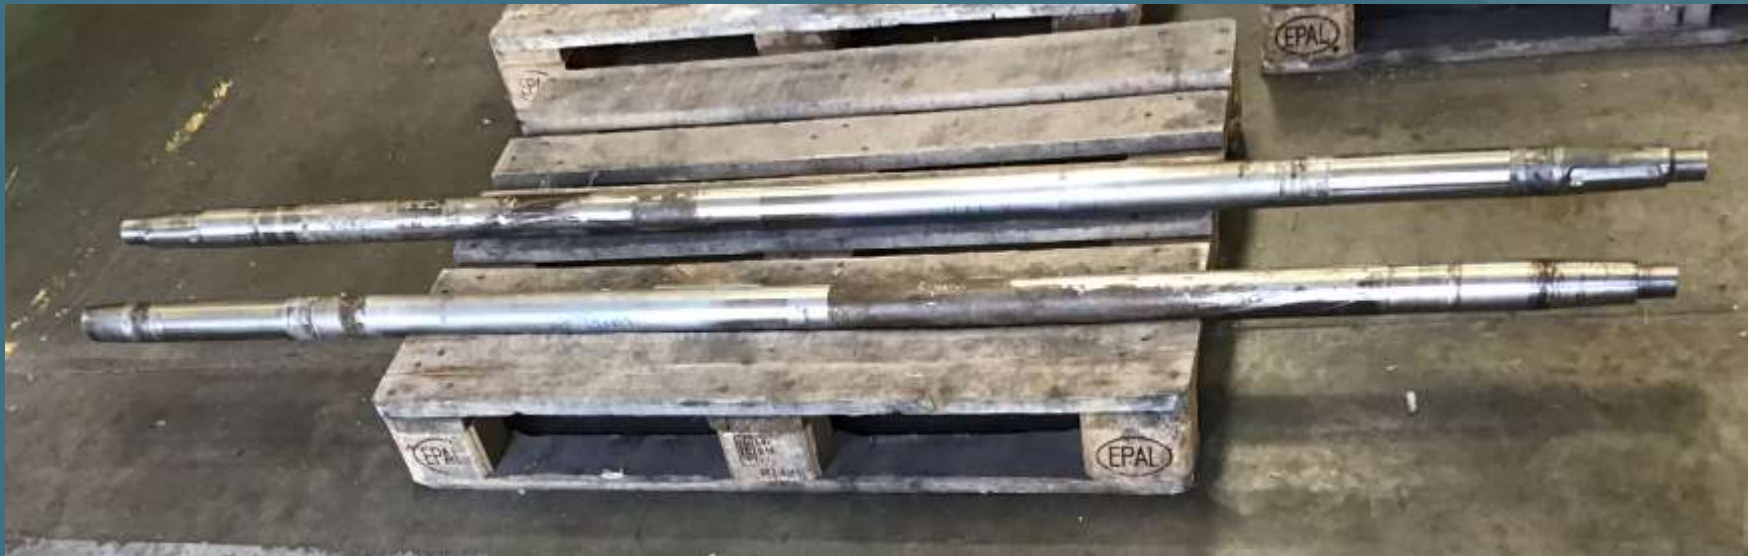
- Propeller shaft from a pilot vessel
- Duplex stainless steel
- Impressed current cathodic protection had been utilised.

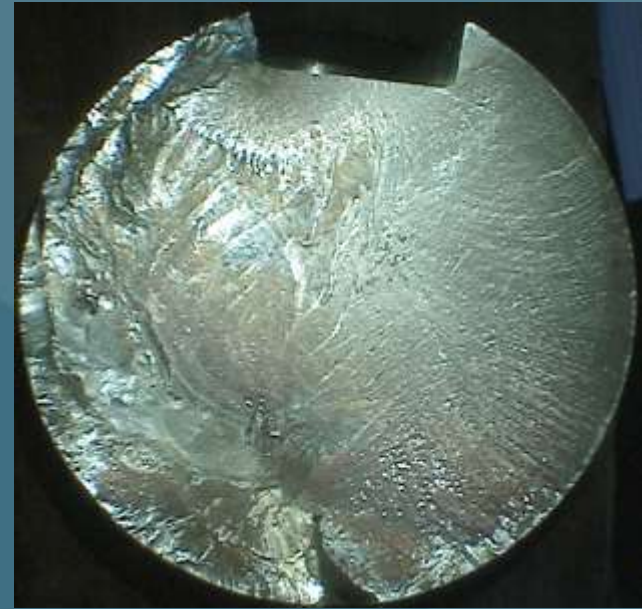
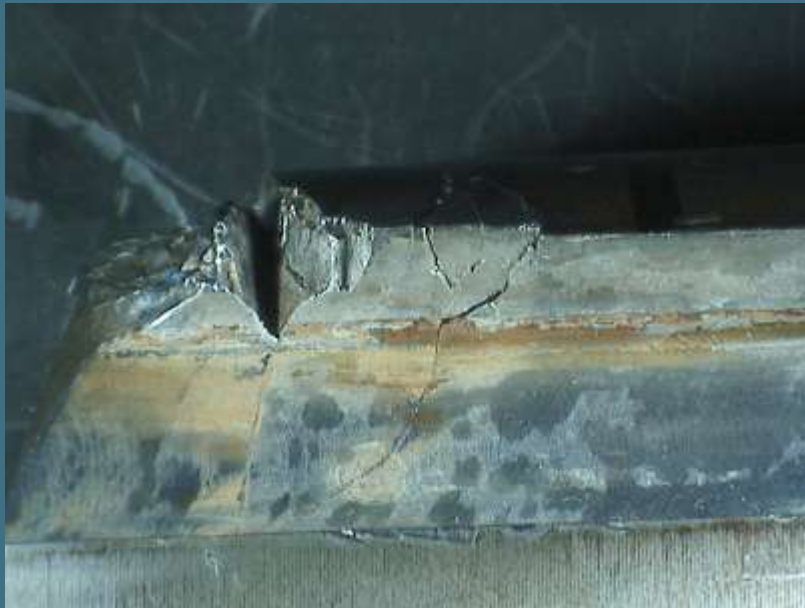
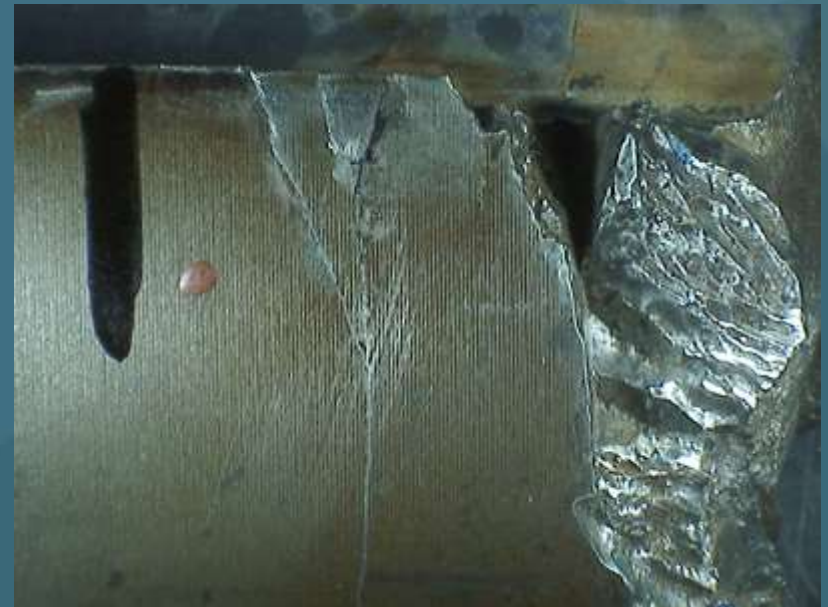
- River lines radiating from the keyway
- Brittle fracture mechanism
- Multiple secondary cracks initiating from the keyway

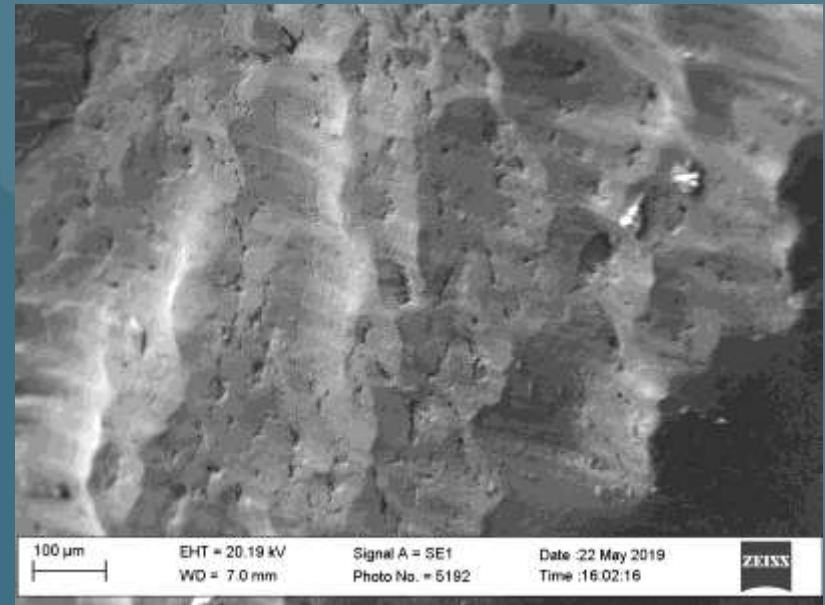
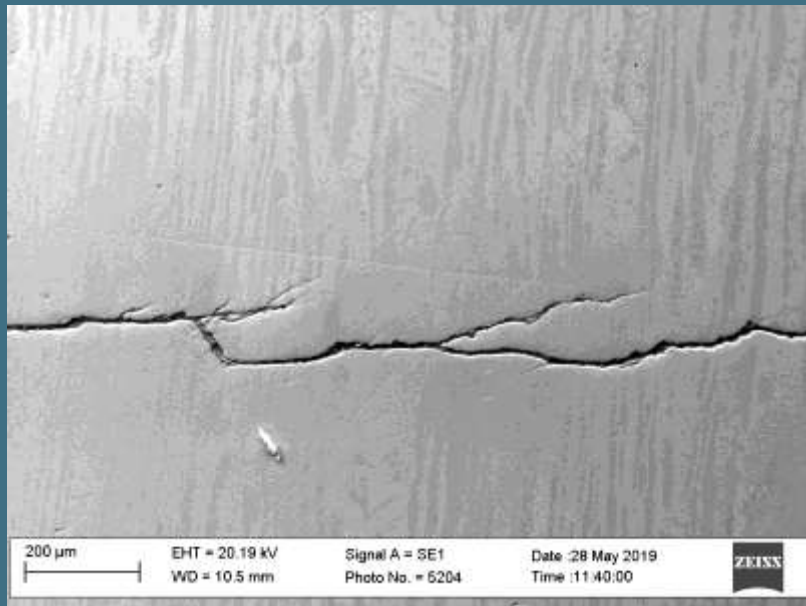
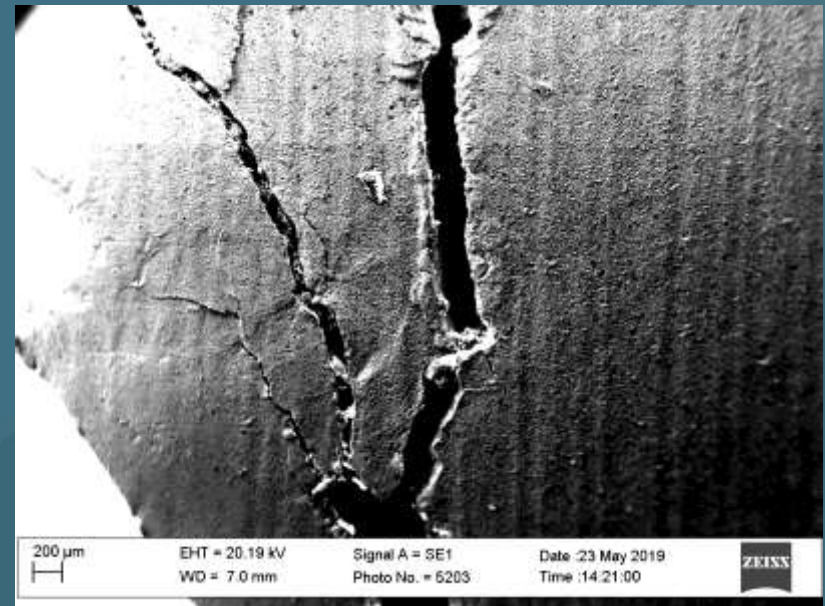
- Fracture surface on a micro scale exhibited significant damage

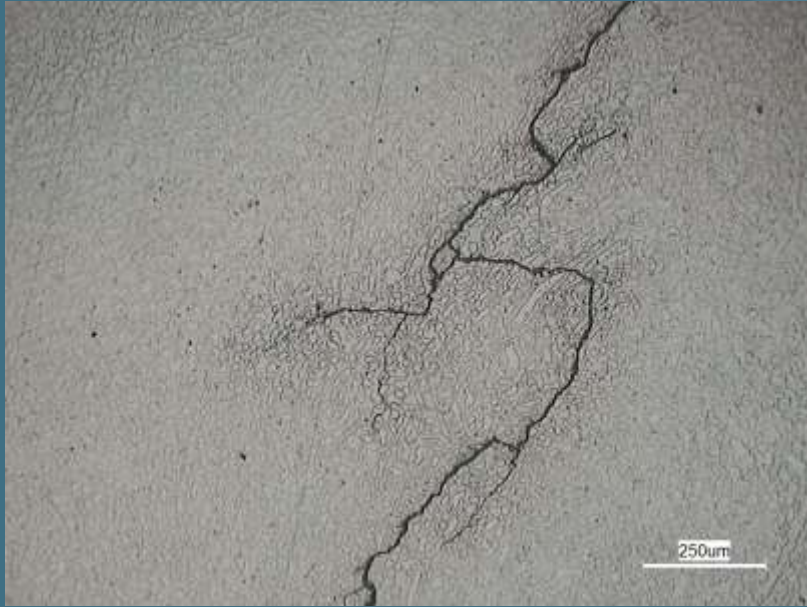
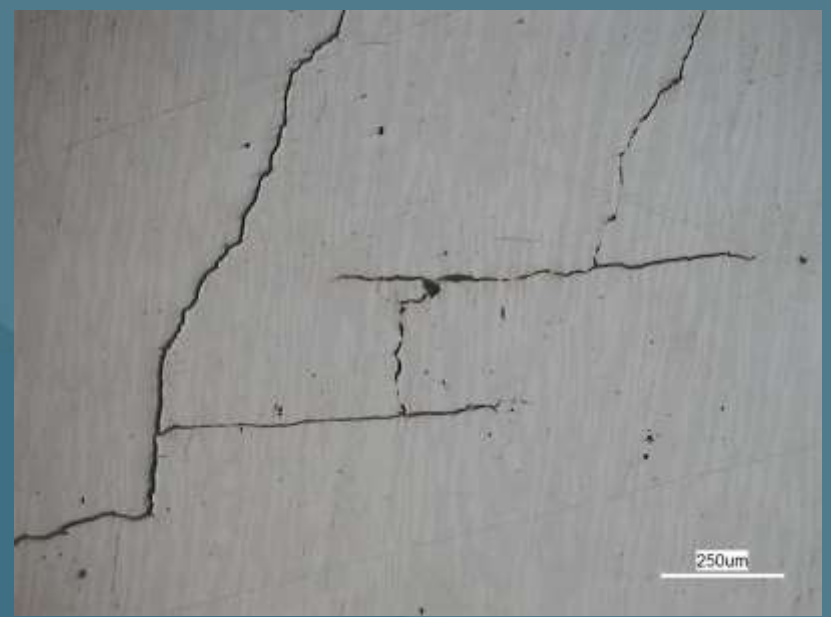
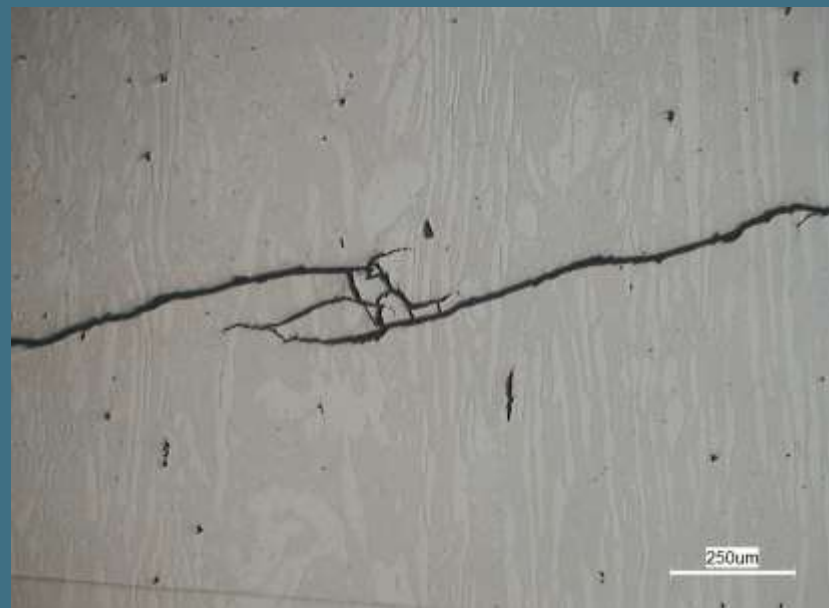
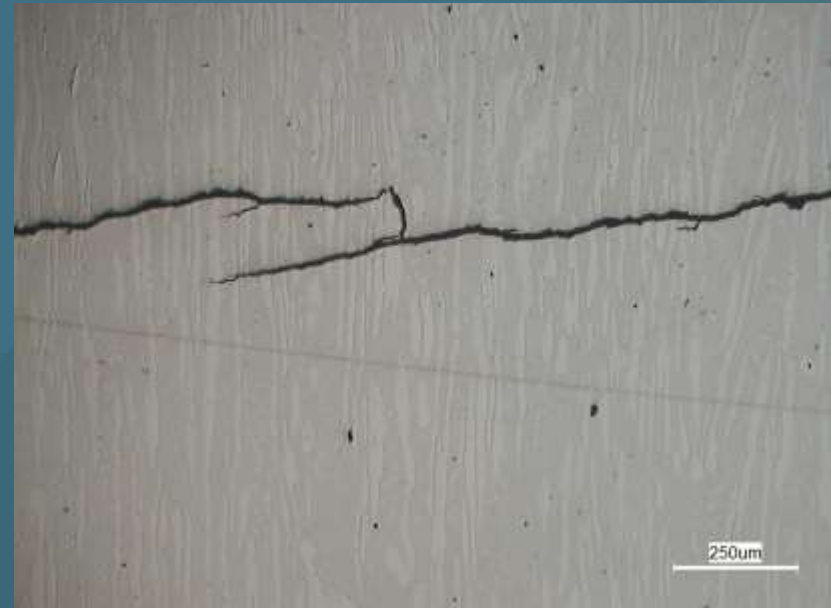
- The deposit within the cracking contained significant levels of chlorine and sulphur.

- Mechanism was deduced to be **Hydrogen Induced Stress Cracking (HISC)**
  - Hydrogen atoms form as a consequence of the cathodic protection.
  - Hydrogen atoms can either combine to form molecular hydrogen or become absorbed in the metal matrix.
  - For a susceptible material, this can lead to hydrogen cracking.
- The vessel adopted zinc anodes which were mounted directly on to the propeller shaft
- The vessel spent 80% of its time within freshwater and 20% at sea. Zinc anodes are typically employed for seawater environments, magnesium for freshwater.

- Review design of the CP system relative to the operating waters. Aluminium can be used in both seawater and freshwater.
- Ensure that the appropriate potential is used for the material grade.
- Inspection to be carried out periodically i.e. DPI

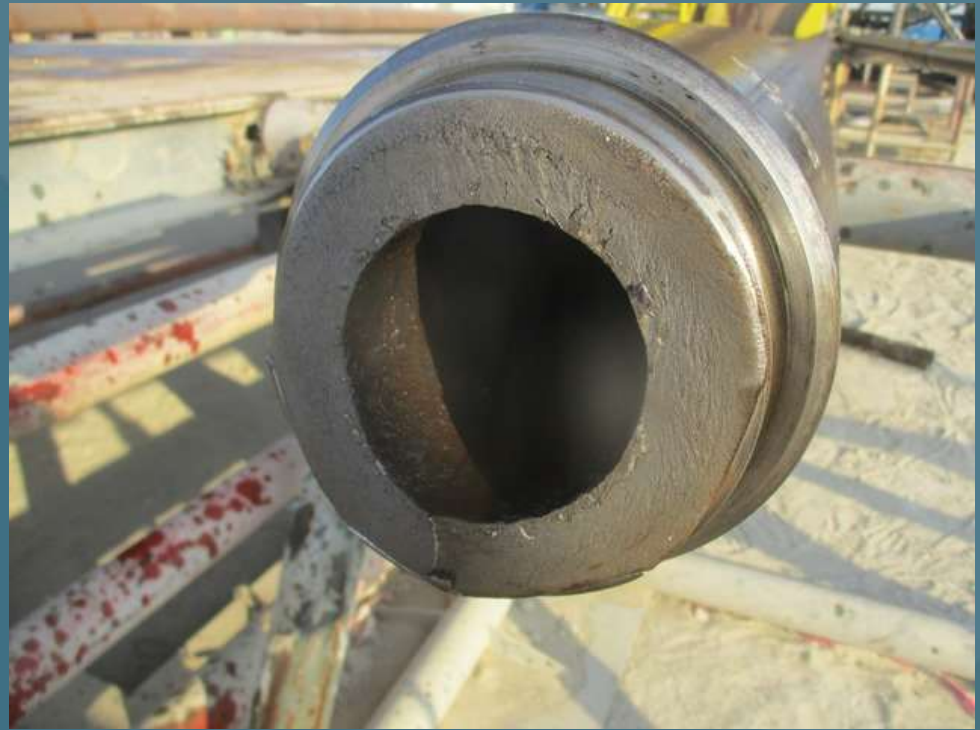
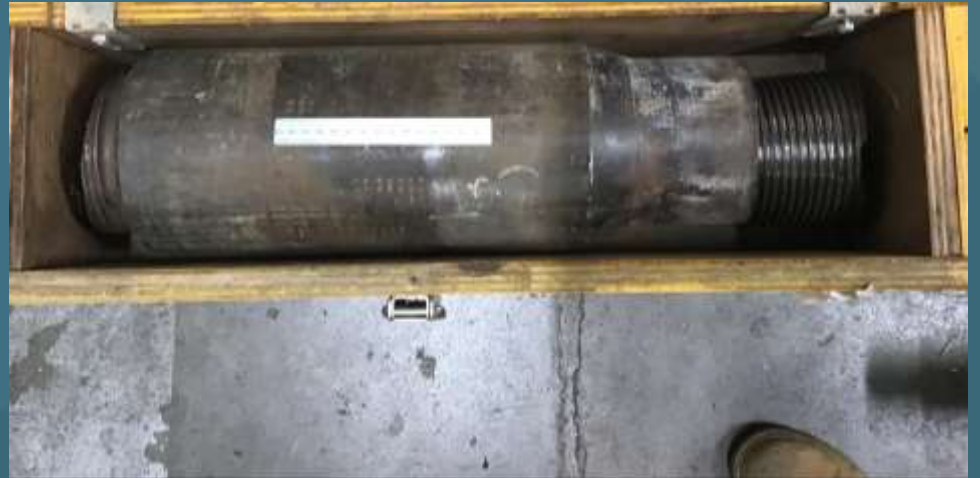
- 5" Heavy weight drill pipe threaded connection
- Mud temperature was approximately 38 degC.
- 4140 alloy steel
- Failed after 247 hours of drilling

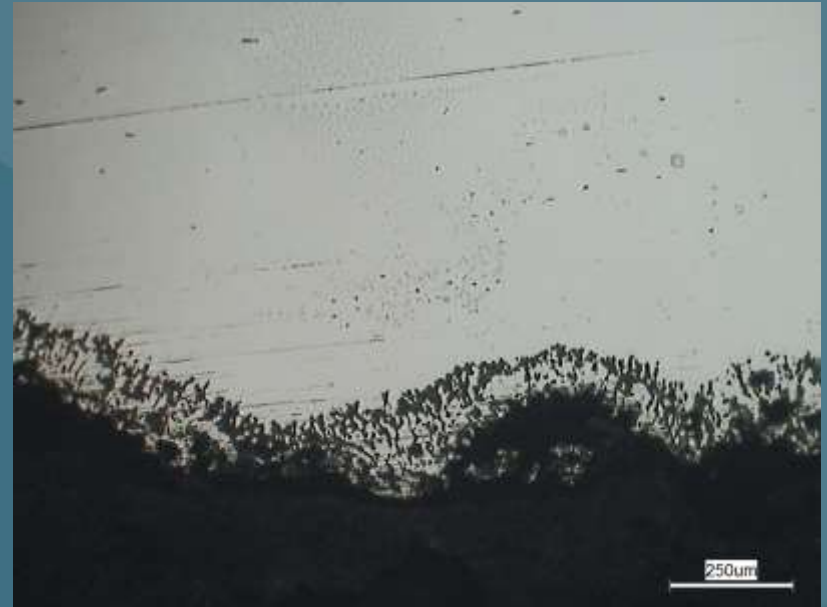
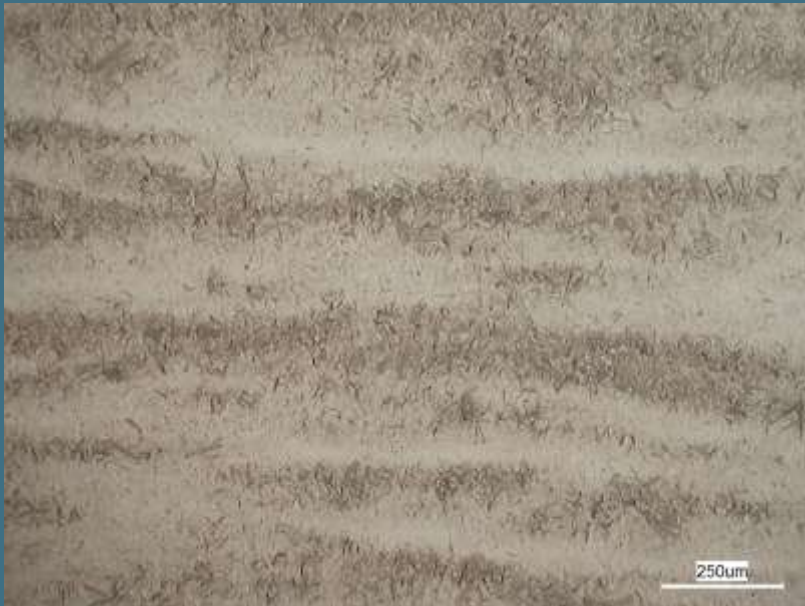
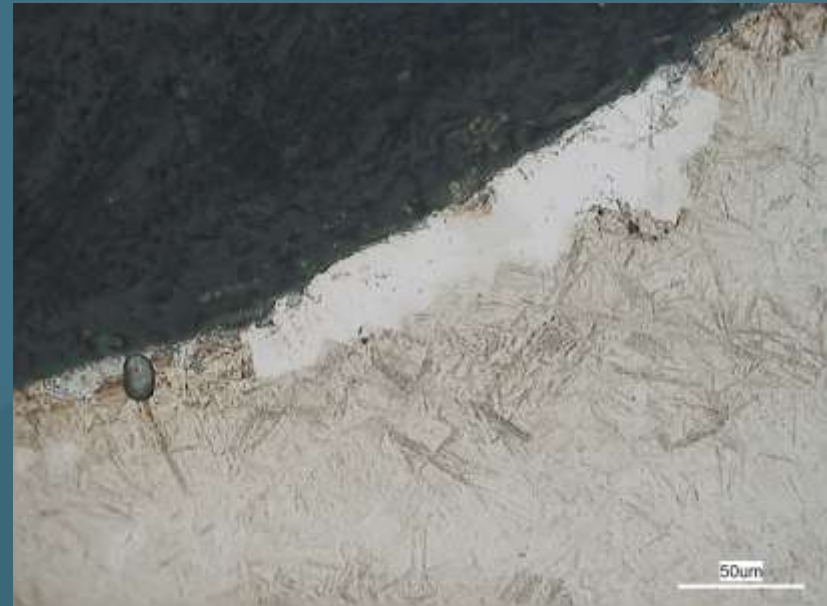
- Selective attack along internal surface
- Deposit contained significant levels of sulphur (up to 30%).
- Hardness levels were up to 520 Vickers. Material grade specifies a range of 302-362 Vickers. Light etching layer was 630 Vickers.

- Failure was attributable to sulphide stress corrosion cracking.
  - Occurs under the combined influence of a tensile stress and corrosion in the presence of water and hydrogen sulphide.
  - Tends to occur at temperatures below 82°C.
  - Susceptibility is primarily dictated by a material's hardness. 200 HV is generally used as the safe limit for carbon and low alloy steels.
  - The hardness levels for the pin were exceptionally higher than this level and the maximum specified for the material specification. Therefore, the pin would be considered highly susceptible to sulphide stress corrosion cracking.

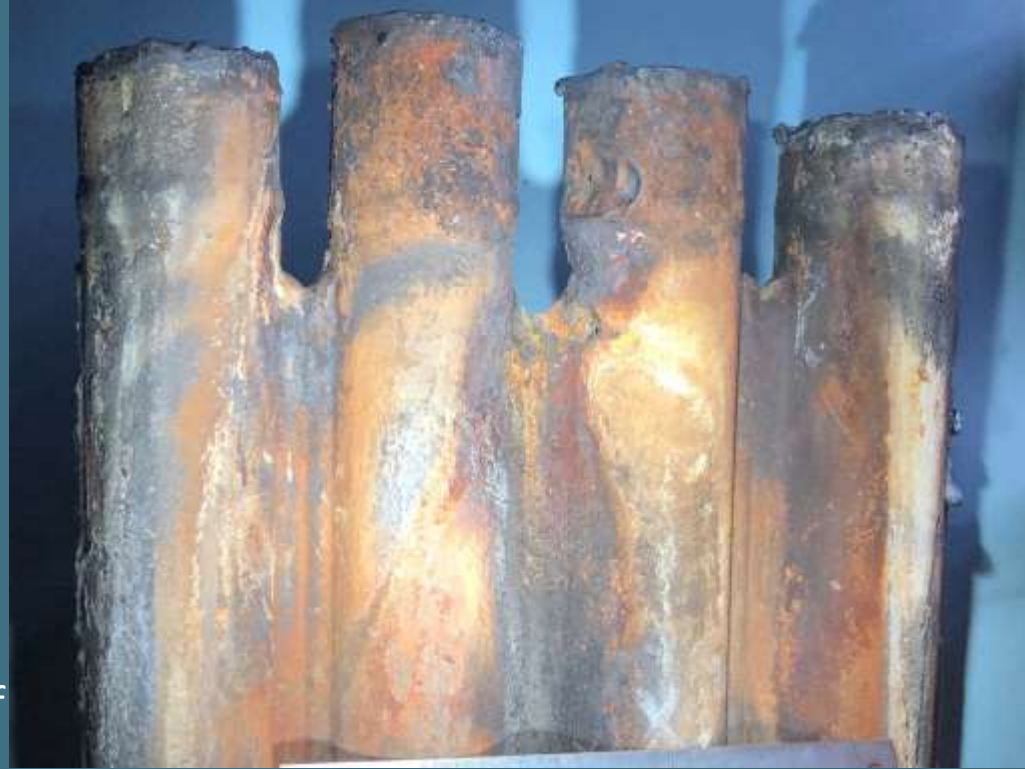
- Rear waterwall tubes extracted from the main boiler of an LNG carrier.
- The crew experienced limitations in steam production when attempting to operate the main turbine at high load.
- Inspection found evidence of significant water ingress about the manipulated tube immediate to the retractable soot blower lance sleeve
- Carbon steel
- The design pressure was in the region of 76 – 78 bar, which facilitates a saturated steam temperature of approx. 300oC.

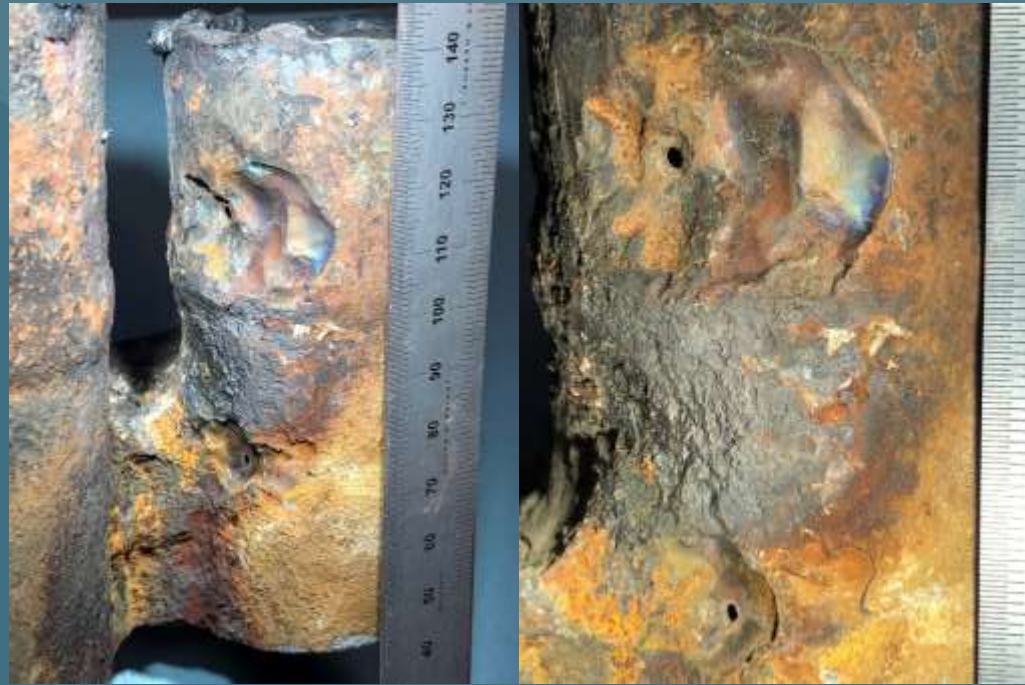
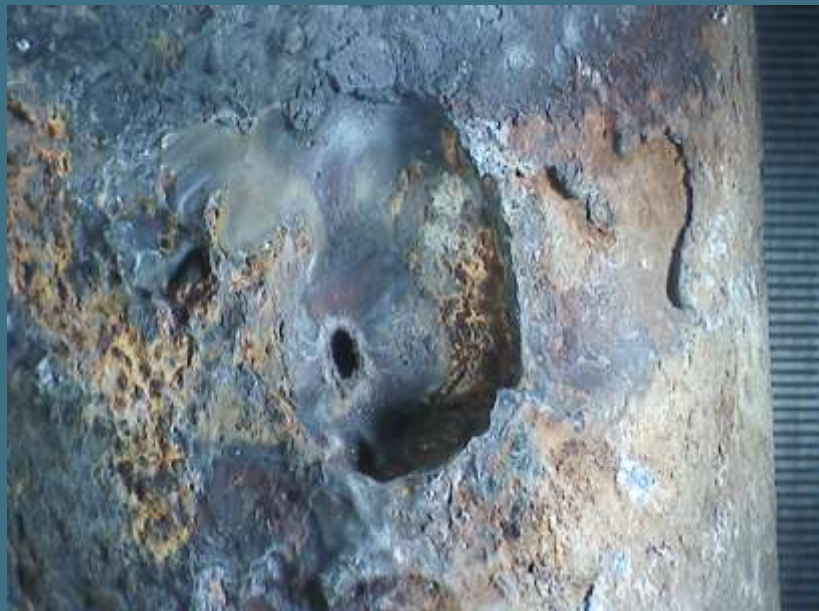
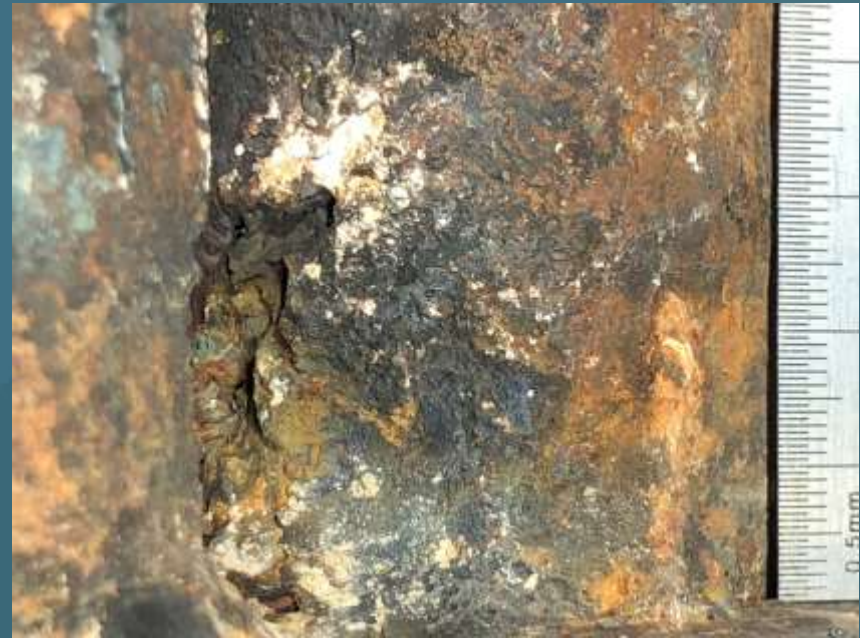
- Scale evident at the external surface was brown, yellow and white in colour.
- 3 pinholes were present
- Smooth undulating surface, almost scalloped in nature.
- Areas of the surface were pockmarked in appearance

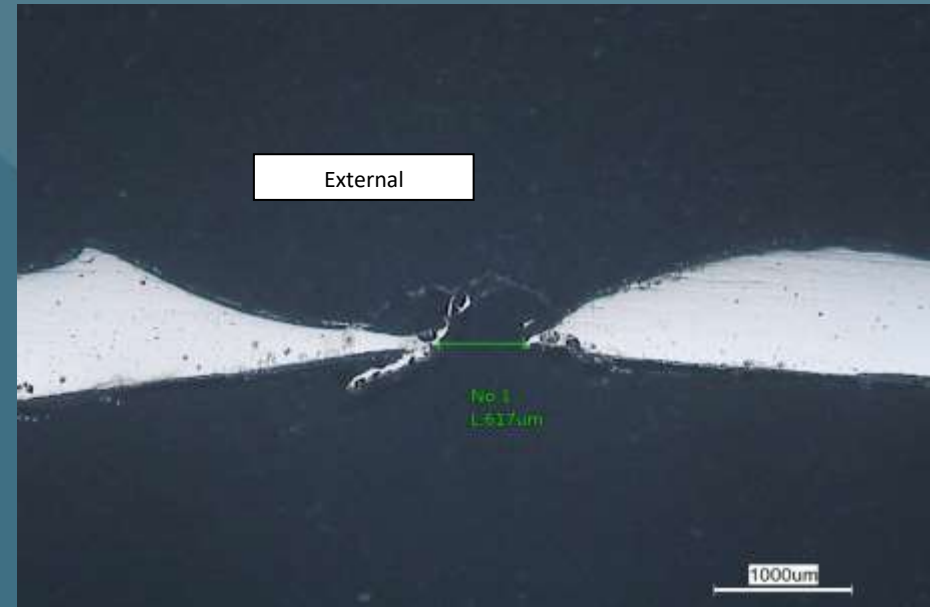
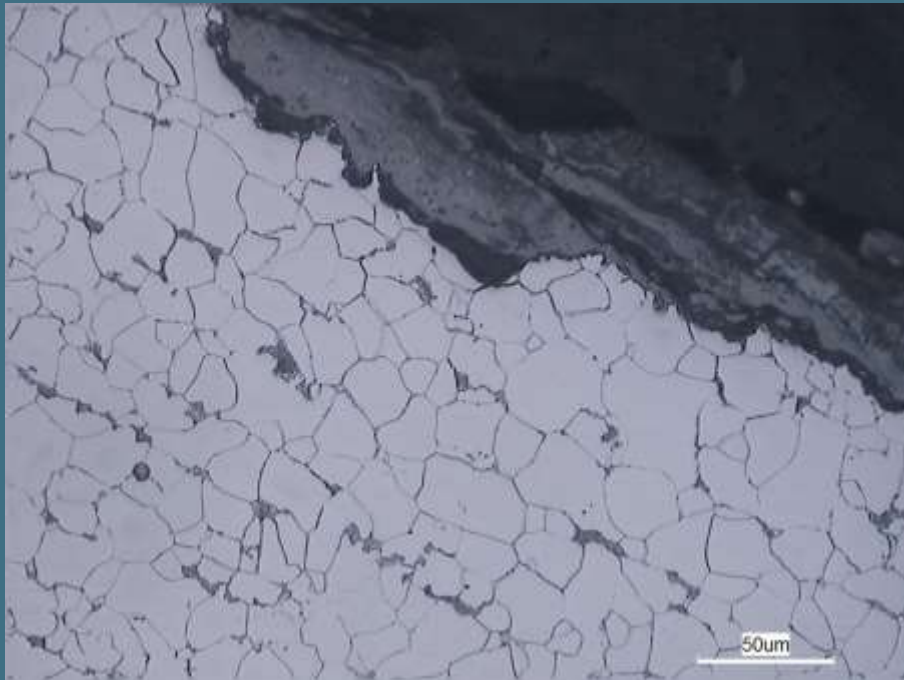
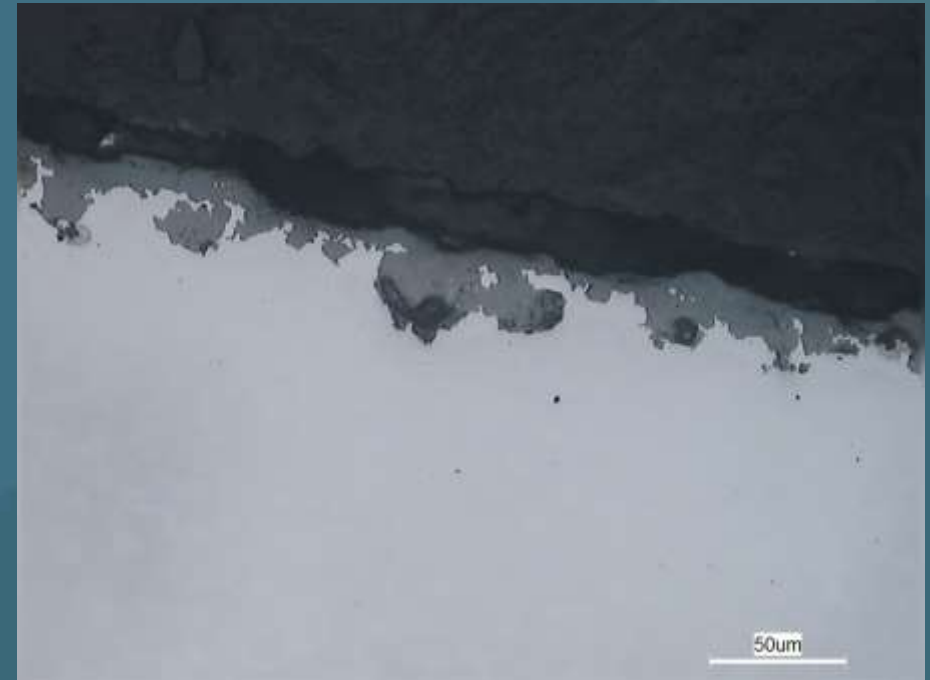
- Microstructure was as expected
- Pinhole was associated with a shallow gradient of wall loss
- Pockmarks/pits were evident along the external surface
