# Failure Analysis – An Insight Into Forensic Investigation, Failure Mechanisms & Prevention

26<sup>th</sup> November 2024

Sarah Bagnall

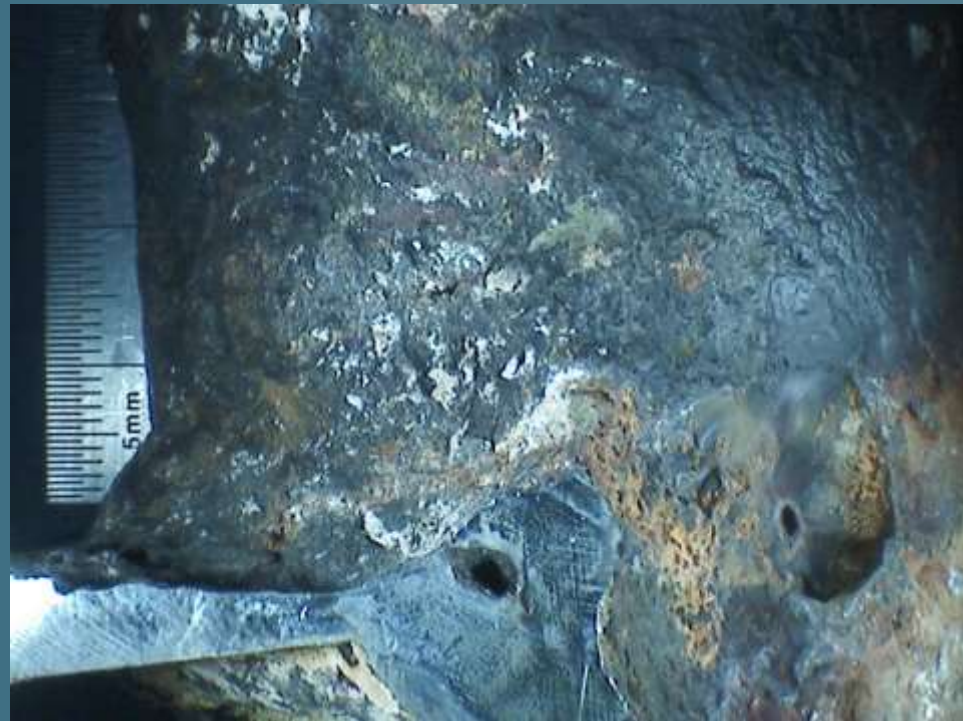
- Corrosion deposit consisted of iron sulphate hydrate, calcium phosphate & hematite
  - Iron sulphate hydrate is produced when concentrated sulphuric acid forms on steel surfaces and reacts with the underlying steel.
  - Calcium phosphate is one of the more common components of boiler deposits, and forms when phosphate salts used to treat boiler water preferentially precipitate with calcium.
  - Hematite is a non-protective iron-oxide formed in oxygen-rich concentrations and can act as binder species; allowing for other phases to accumulate within the deposit.

- Mechanism was identified as **Sulphuric Acid Dewpoint Corrosion**:
  - Occurs when metal temperatures fall below the sulphuric acid dew point of the flue gas. Generally termed “cold-end corrosion” since it generally affects the cooler regions.
  - Sulphur is present in heavy oil and during combustion, sulphur oxides are generated, a small portion of which becomes  $\text{SO}_3$ .
    - As the exhaust gas temperature reaches the dew point or lower, vapour-phase sulphuric acid forms.
    - If this contacts the lower-temperature metal surface it can condense as liquid sulphuric acid, attacking the underlying metal.
  - Temperature at which sulphuric acid condenses varies between  $116 - 166^\circ\text{C}$  or higher
    - Depends on the  $\text{SO}_3$  and water vapour concentrations in the exhaust gas.
    - The dew point increases with  $\text{SO}_3$  content and moisture content.

- Controlling corrosive quantities of sulphur trioxide in the flue gas
  - Operate the boiler at or below 5% excess air to the burners
  - Minimise air infiltration
  - Specify fuels with low sulphur content
- Controlling the level of moisture in the flue gas
  - Specify fuel with low moisture content
  - Prevent tube leaks
  - Reduce amount of soot blowing

- Controlling metal surface temperatures
  - Requires substantial design changes
- Feeding of fuel additives and/or cold end additives i.e. MgO
- Periodic removal of ash deposits
- Application of a corrosion inhibitor following cleaning and drying during shutdown. Humidity control can also be implemented.
- Weathering steels, such as COR-TEN and S-TEN, have been reported to be highly resistant to sulphuric acid dew point corrosion in comparison to low carbon steels and the majority of stainless steels.
