CORROSION UNDER INSULATION

René Goderie

December 2024

A VERY SIGNIFICANT "NEAR MISS"

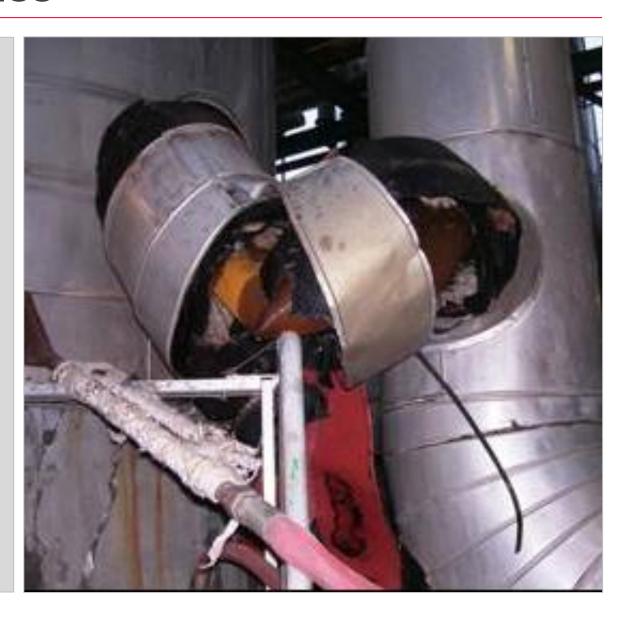
Sudden failure of a 8 inch carbon steel high pressure hydrocarbon line due to Corrosion Under Insulation

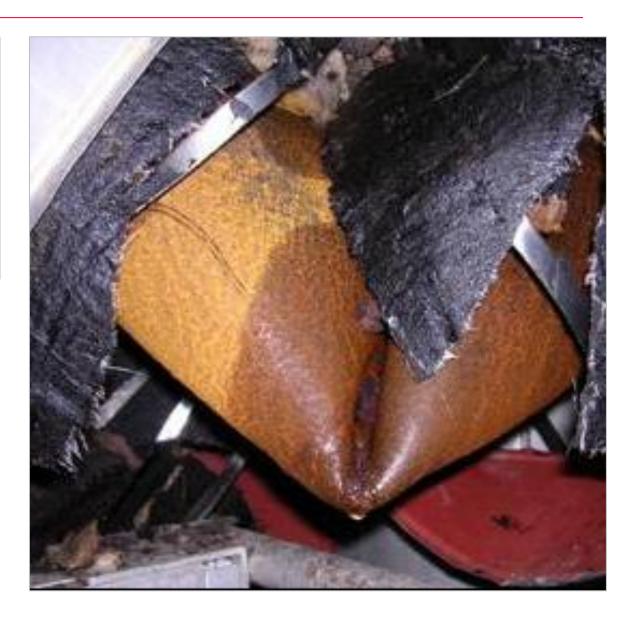
Fortunately, the pipe failed with such force....that the pipe bent in two locations such that it essentially self-sealed to line willed with ethylene and other hydrocarbons

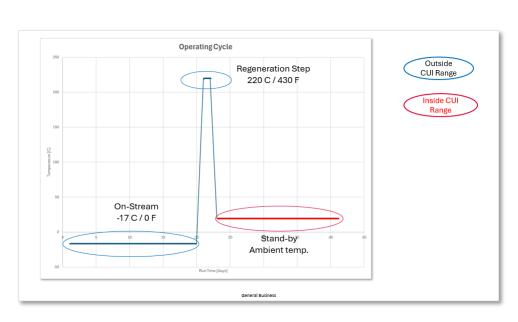
- Piping was a 30 year old,
- Schedule 20, carbon steel
- Regeneration line to a cracked gas dryer of an ethylene plant (one of two parallel drying trains).
- Due to the regeneration service, the piping alternates between three different conditions, and the location of failure was where operating temperatures cause frequent or continuous condensation and re-evaporation of atmospheric moisture:
 - Regeneration condition (4 bar, 220° C)
 - On stream time: 20 days (30 bar, -17° C)
 - Regeneration time: 24 hrs (220° C)
 - Standby: 19 days (ambient temperature)

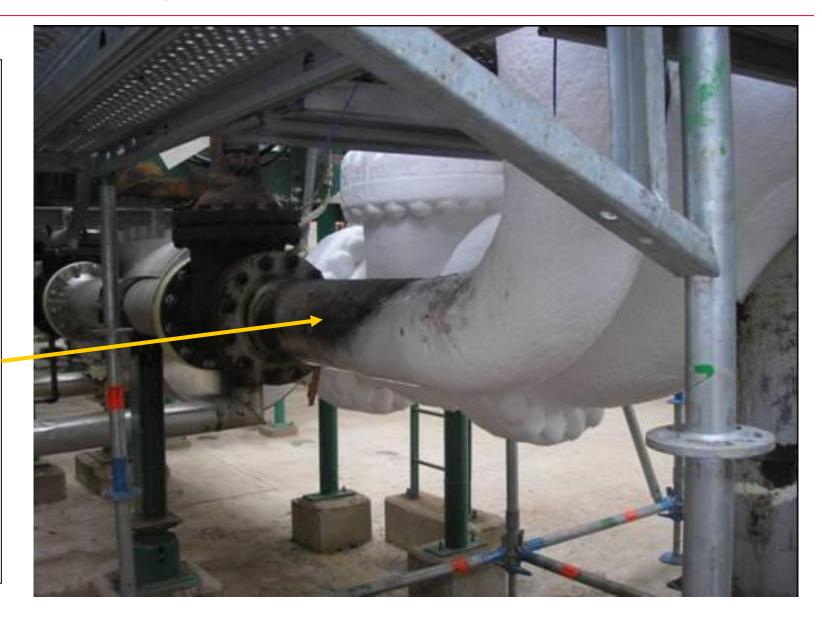
Location of pipe failure.

Note that the transition from external icing to no icing at this location when the line is not in service. This established a humid boundary condition, which is a classic CUI susceptible location.

Cause #1 - Inadequate Inspection in 2004 and earlier

Not according to e.g. API510 / 570
Insufficient Insulation removal / NDT
Inspection

Cause #2 – Operating conditions unknown

Mechanical Integrity Programs can not rely solely upon contract inspectors and need adequate involvement of plant personnel familiar with plant operations.

Training of all involved disciplines

CUI Emphasis Program
