**Assessment of Corrosion under Insulation
and Engineered Composite Wraps using
Pulsed Eddy Current Techniques.**

Presentation Outline

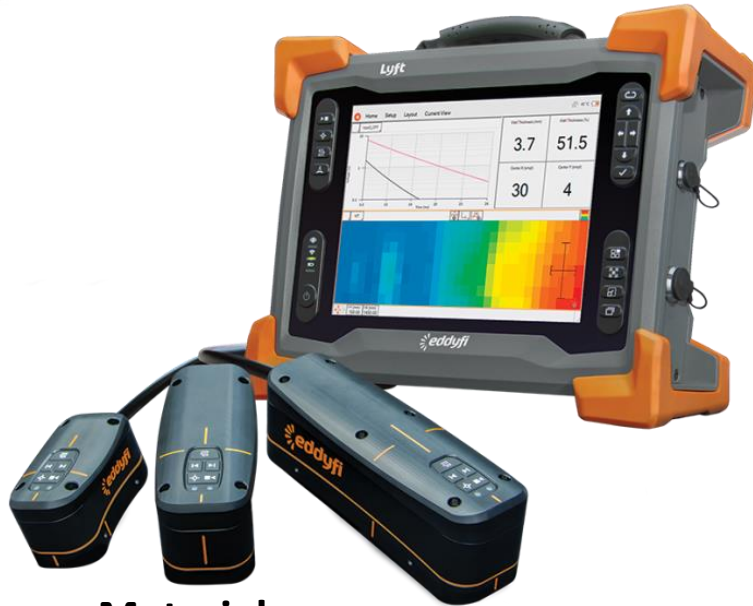
Eddyfi LYFT Instrument

- **Materials:**
Carbon steel
- **Lift-off range:**
up to 300mm (12")
- **Wall thickness:**
up to 100mm (4")

- **Weather jackets:**

Aluminium, stainless steel, galvanised steel

- **Probe:**

PEC-089-G2-HT05S

Footprint 95.2 mm

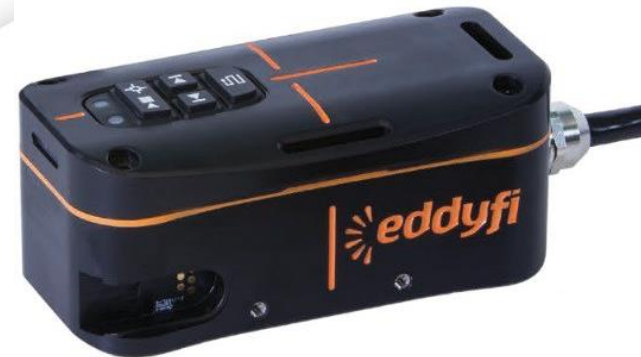
MAXWELL PECT Instrument

Circumferential Footprint 124.5mm

- **Wall thickness range:**
3 – 50 mm (0.12" - 2")
- **Insulation covers:**
Non metal, aluminium and stainless insulation covers; limited galvanised weather sheeting

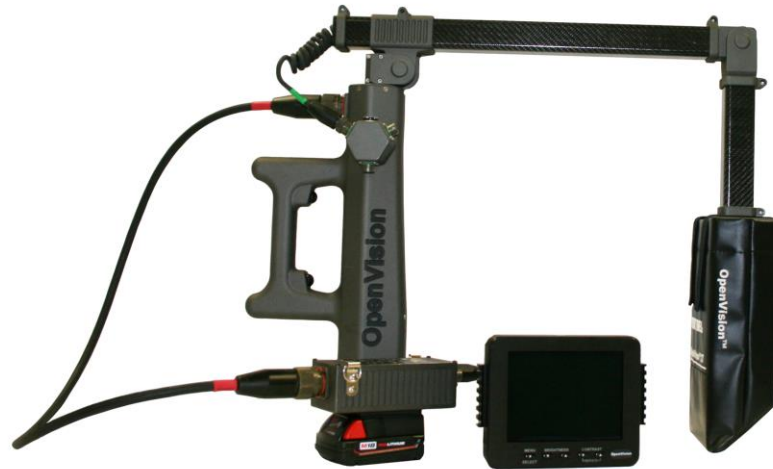
Radiography

Initial trials with Sentinel QSA Global Open Vision equipment.

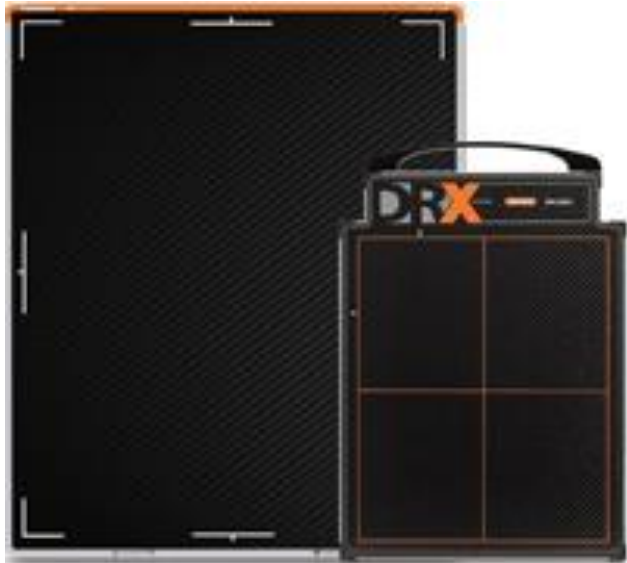
Radiography

Two Digital Detector Array (DDA) systems were evaluated
Little or no difference in technical performance

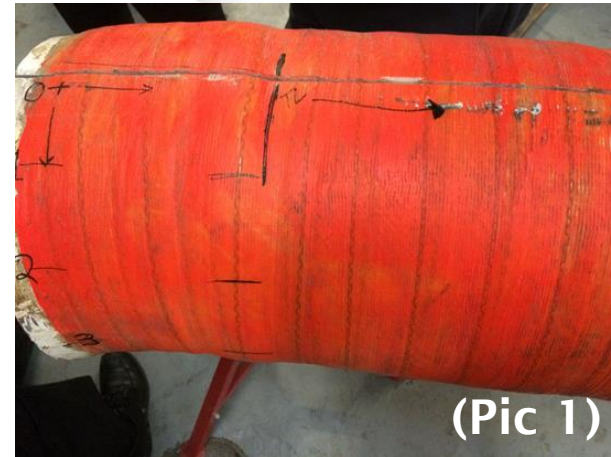
(Pic 1)

Sample : Pipe OD 323mm

Thickness: 8.3mm

Length 1200mm

Engineered Composite Wrap 9mm

- Sample inspected after being removed from service (picture 1)
- After inspection a section of pipe was cut and the ID exposed to reveal a large scabbed area after initial cleaning. (picture 2)

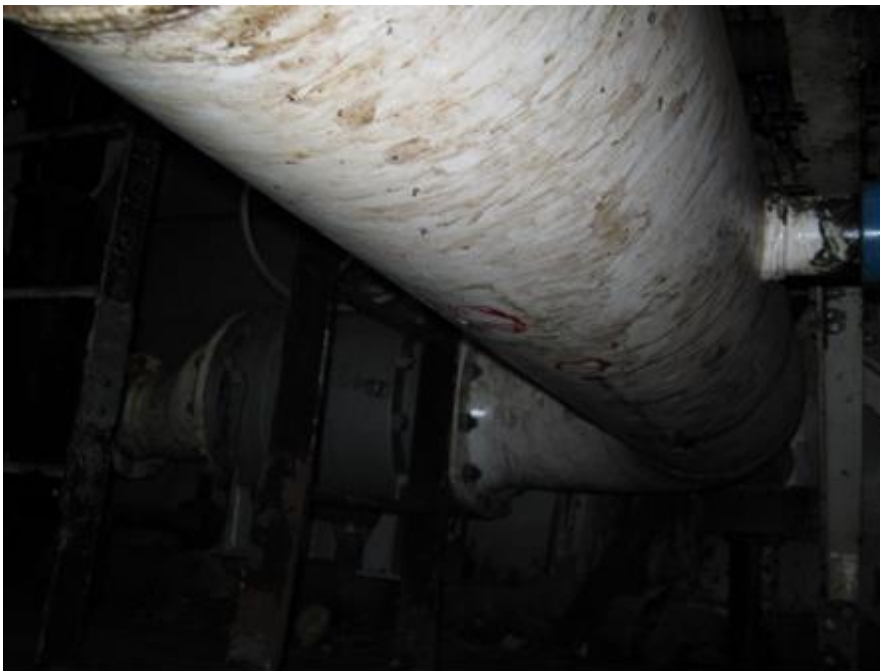
Initial Work – Anomaly Report

- The original anomaly report identified two areas
- Area of anomaly A 80mm x 30mm 6 o'clock position 5.2mm minimum
- Area of anomaly B 20mm x 30mm 6 o'clock position 4.9mm minimum

Cross Section Of Defect

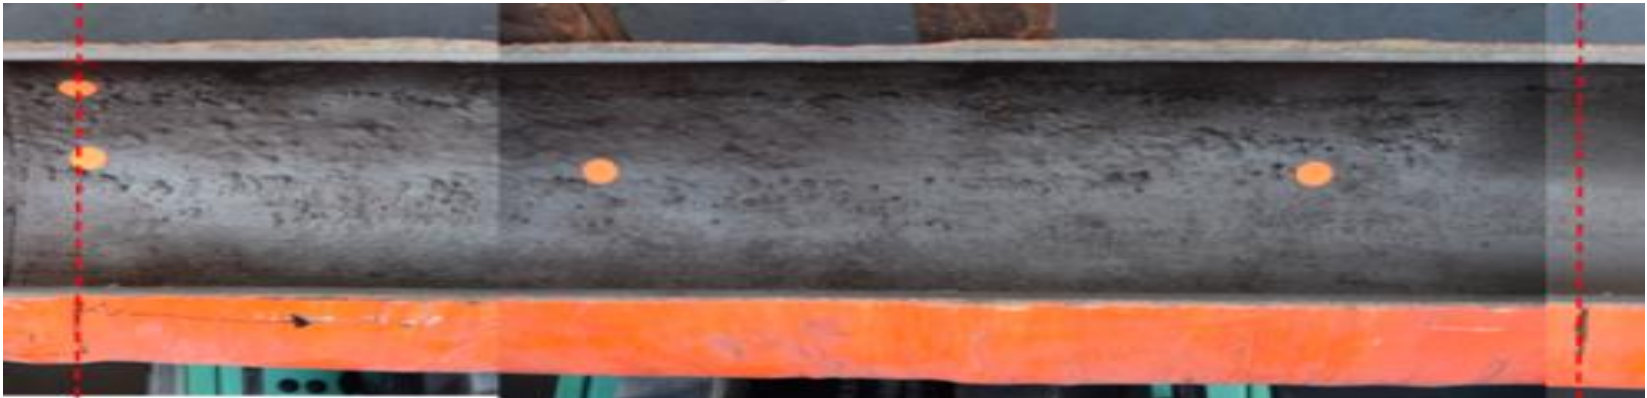
Initial Work – PEC Results

- PEC Results show large area of general wall loss containing deep pitting along the length. The minimum reading recorded by the PEC 4.2mm.

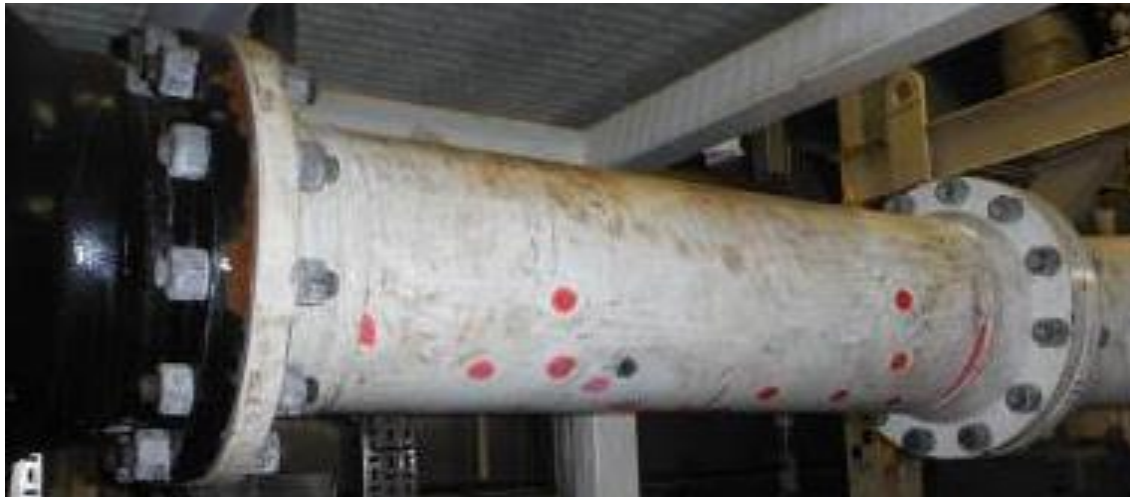
Example 1

- The original anomaly report identified many areas of wall loss
- All anomaly's predominantly between 3-9 O'clock positions
- Minimum reading Location 1 3.8mm
- Minimum Reading Location 2 3,6mm

Location 1

Location 2

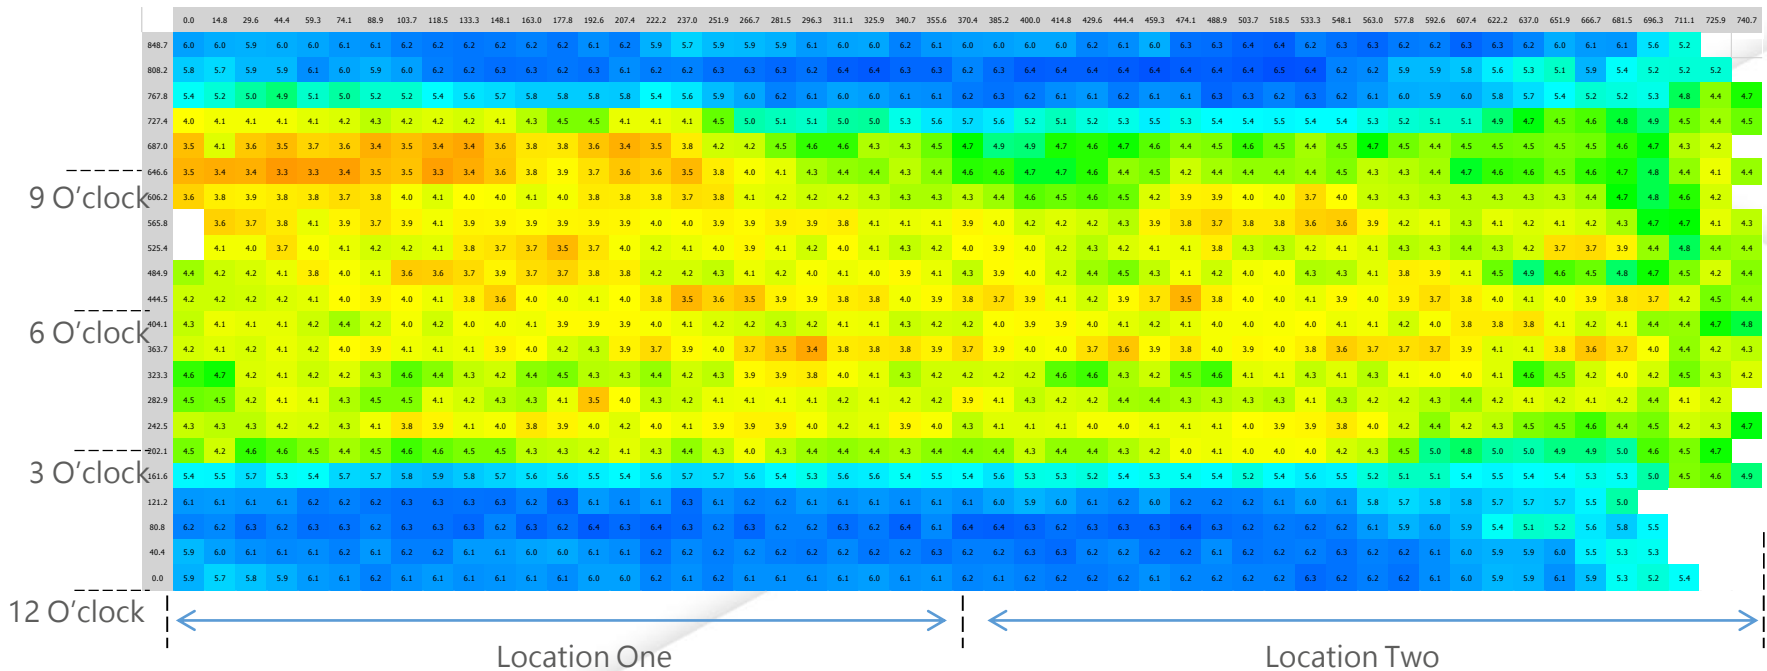
Example 1

- PEC Results show large area of general wall loss containing deep pitting along the length. The minimum reading recorded by the PEC 4.2mm.

Wall thickness values

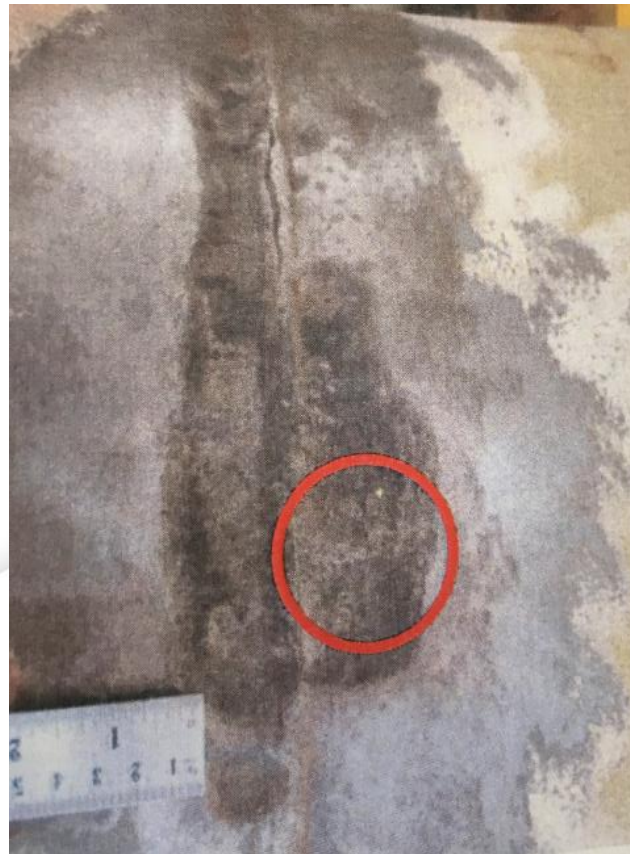
Example 2

- Nominal 7.92mm
- PEC (48% Remaining) 3,8mm
- Measured remaining before wrap applied 3mm

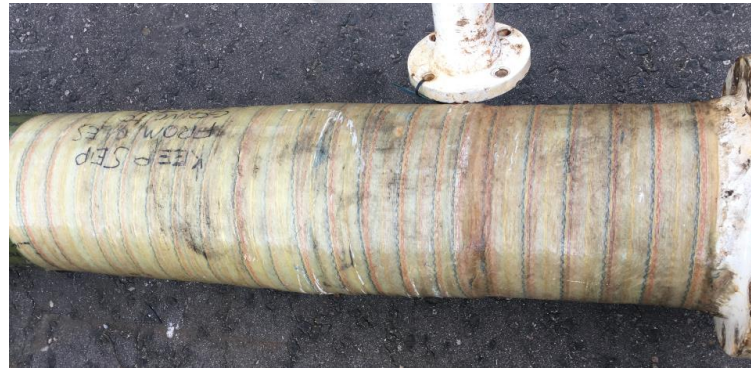
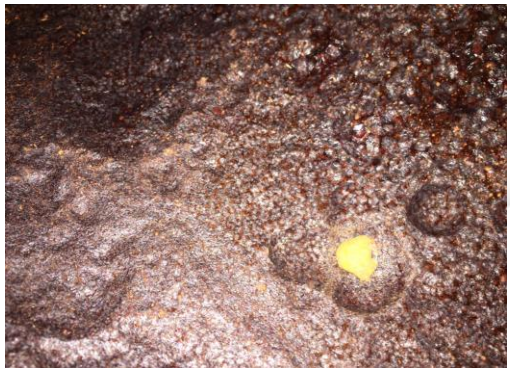
Example 3

- Pitting with leak path through to wrap PEC detected 68% remaining (pit approx. 10 mm diameter hole approx. 5mm)

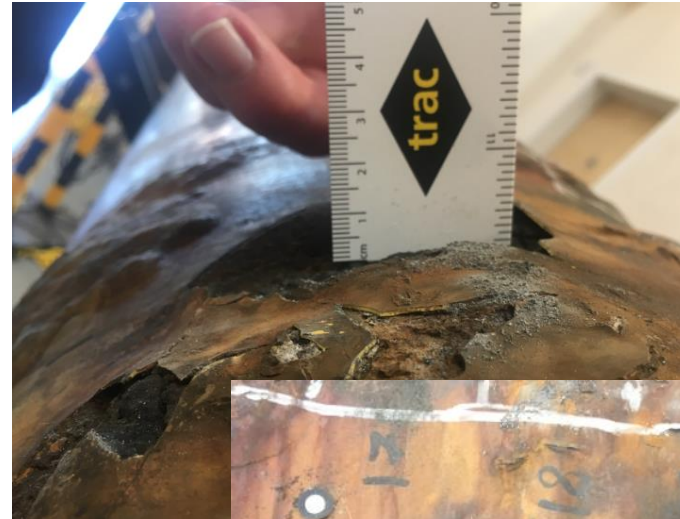
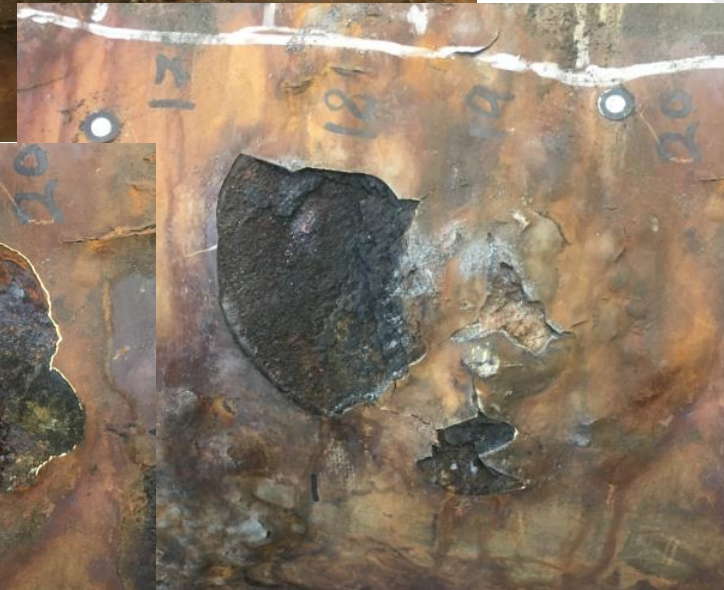
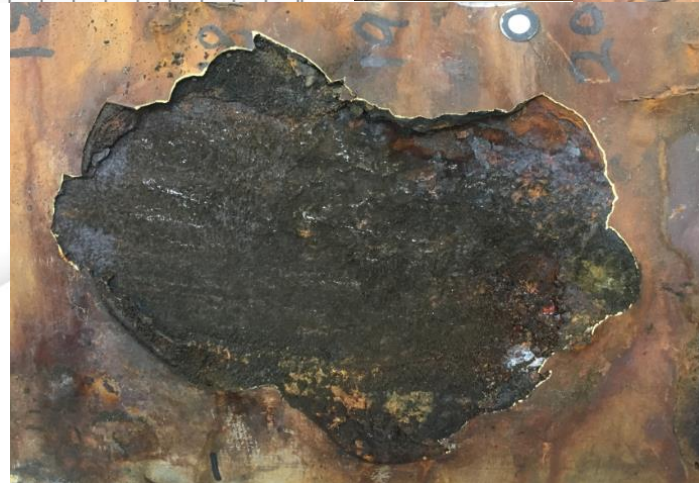
Example 5

- Remaining wall measured through blister then blister removed.
- PEC measured 7.2 remaining
- UT measured 6.8
