DRS Inspection For Challenging Coatings

Dr Alison Craigon

May 2018

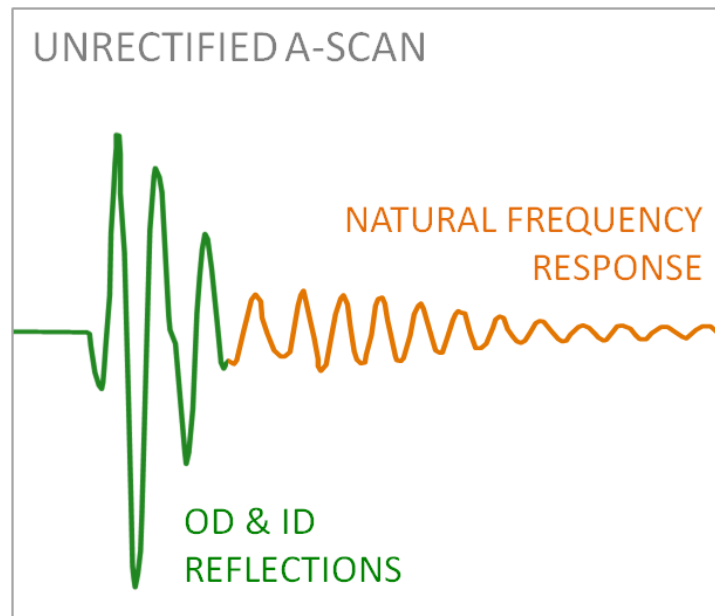
Steel responds, vibrating at natural frequencies related to the WT

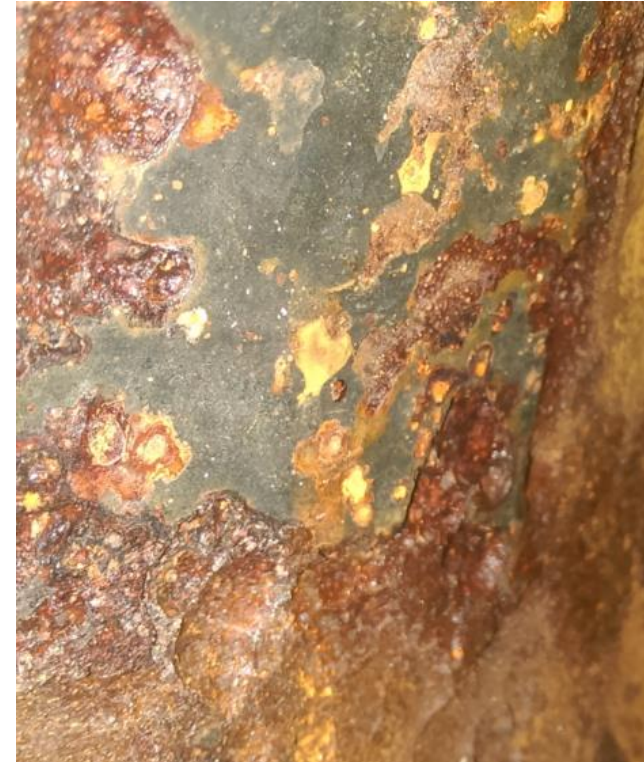
Uneven surface

Severe internal corrosion

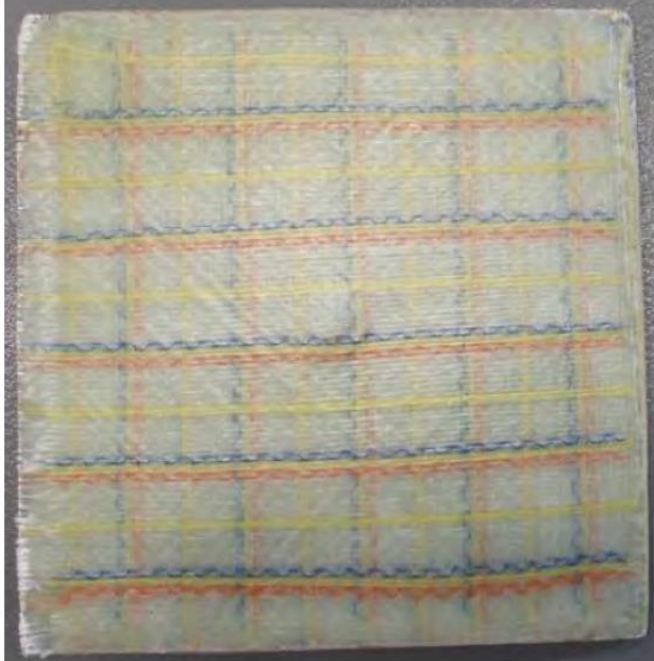
Composite repair on a flat plate

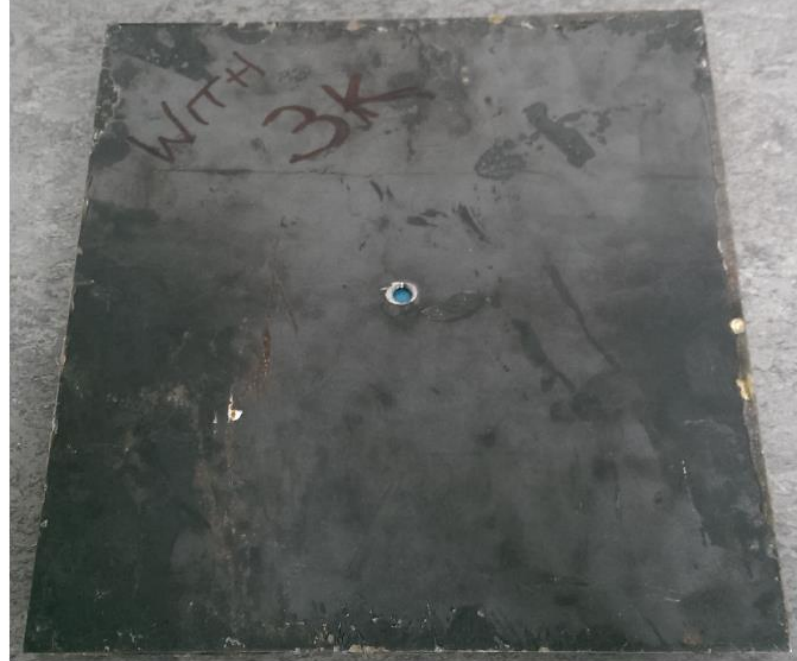
Pressure applied through back of plate to delaminate the composite

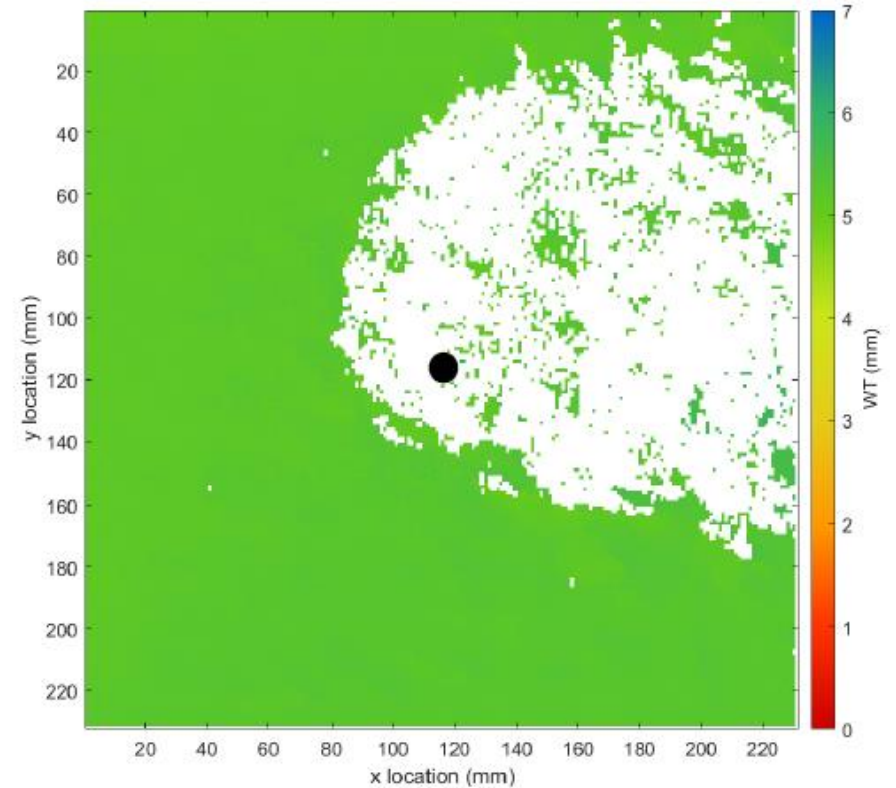
DRS map shows delamination in white

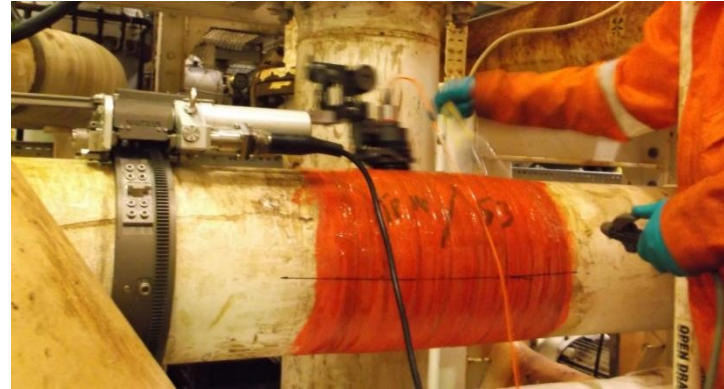
New low-profile scanner can access these areas

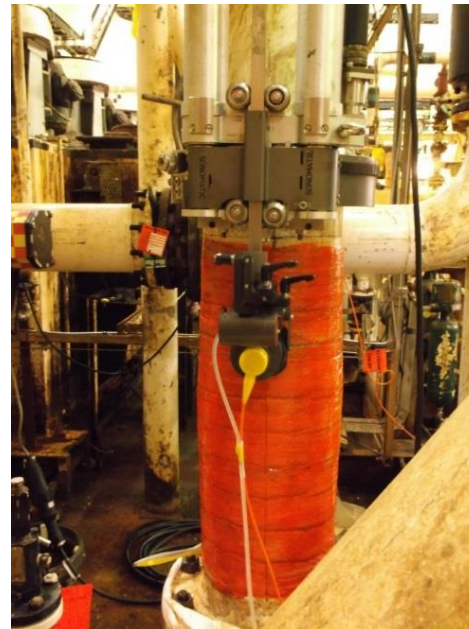
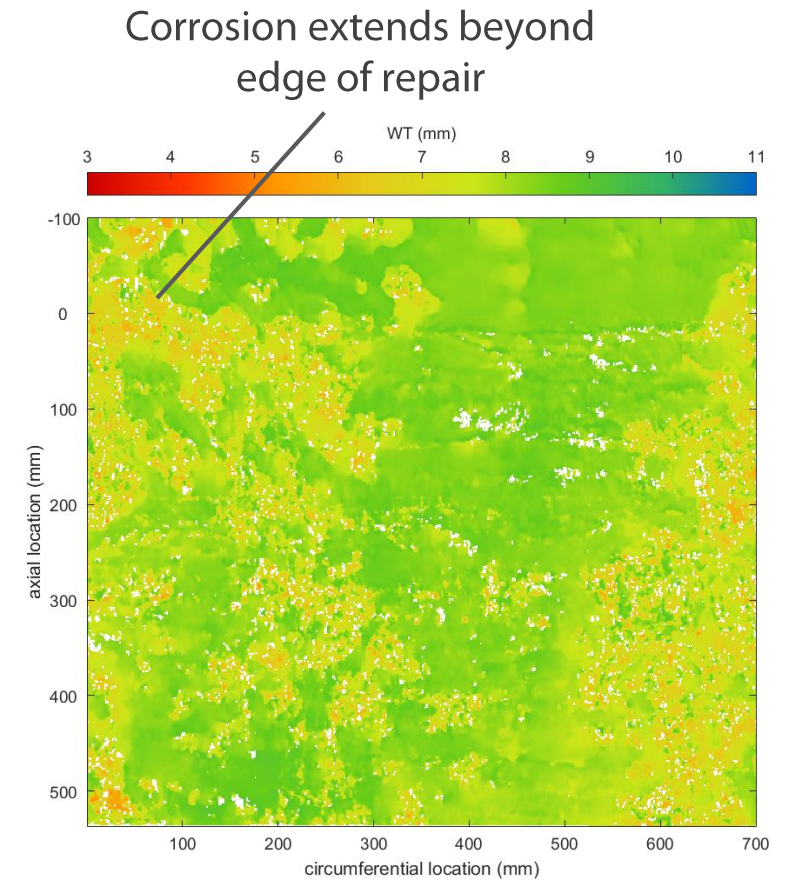
Flaws in composite repair
