# What's the Problem?

Pipework, pipelines, tanks and other metal structures

# What is the Alternative?

#### **Cold Bonding**

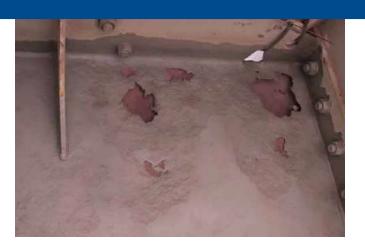
Three main factors cause deterioration on structures

- Environmental Corrosion
- Process Acidic/alkali
- External Abrasion, impact and erosion
- Wear and through-wall defects take place
- Stress concentration nodes
  - A combination of these factors are often found working together e.g. stress corrosion cracking

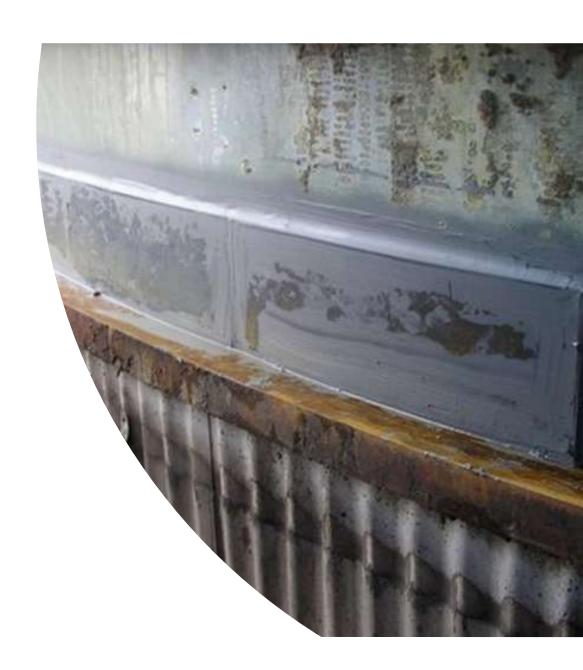
No need for bolts or welding

Think of it as a "composite sandwich"

Cold bonded parts demonstrate better compressive strength, adhesion levels, dissipation of stress, forces and loads

Example: bonding deck, tank external, separator internal fittings

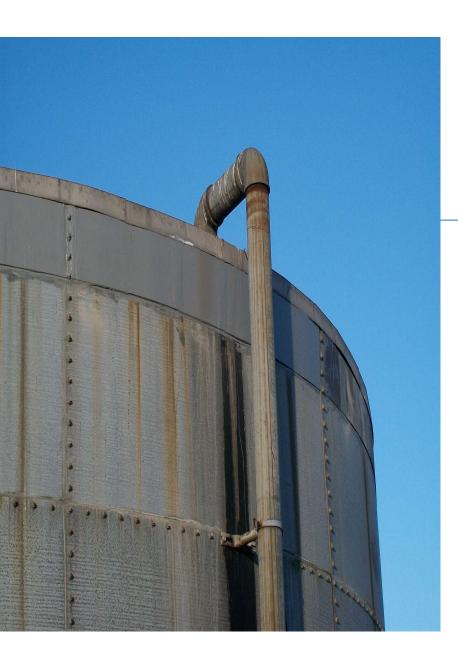
## **Method 1: Hand Calculation**

With that in mind, let's take the example on the left. This is based on a similar, real life application – bonding a plate onto the external of a corroded tank.

#### **Steel Plate**

Profile: 1000mm (L) x 100mm(W) x 4mm (T)

- Yield: 235 N/mm<sup>2</sup>

#### **Adhesive**

- Type: 2-part Epoxy Bonding Agent
- Adhesive Strength (20°C): 22.3 N/mm<sup>2</sup>

The bonded area is 1600mm<sup>2</sup>. Let's take a force of 3000N (pressure) to act from inside the tank across the plates surface. This gives:

Force: 3000 N

Area: 1600 mm<sup>2</sup>

Stress: 1.875 N/mm<sup>2</sup>

Safety Factor: 12

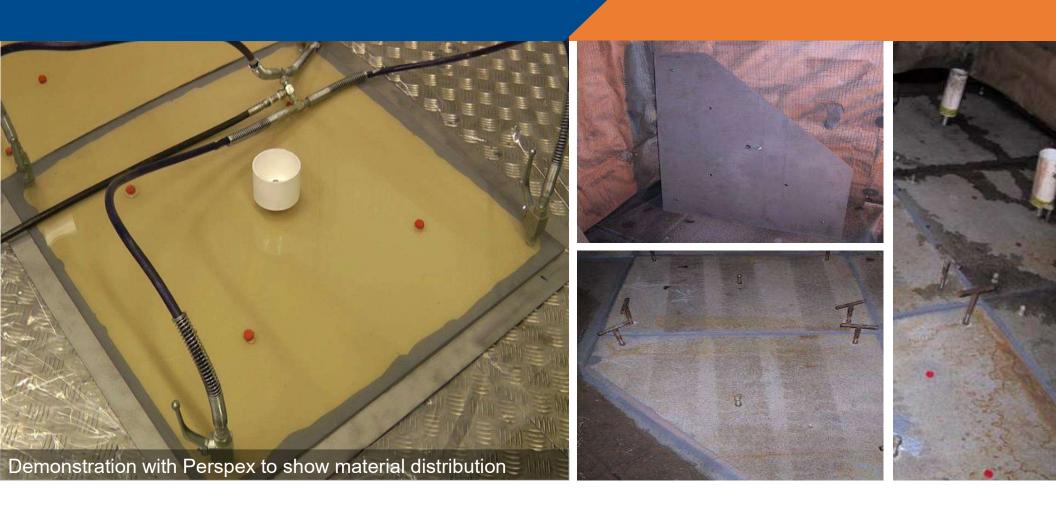
# Injection Bonding Using Fluid Grade Systems

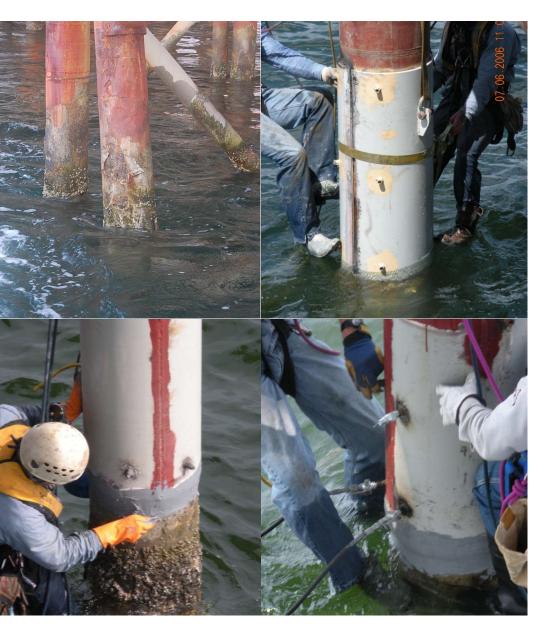
# Protecting Offshore Platform Legs at the Waterline

Platform legs damaged by corrosion and impact from service/crew boats at the waterline.

Due to corrosion and impact damage platform legs were at risk of losing structural integrity. Client wanted to terminate damage to avoid further deterioration. Customer had welded top and sides of half wrap without welding bottom, due to water/wave action. Corrosion had accelerated between the leg and half wrap.

Epoxy filler was used to seal the bottom of split shells, and an epoxy coating was then injected to fill cavity between platform leg and steel wrap.

Products used were Belzona 1161 (Super UW-Metal) & Belzona 5831 (ST-Barrier)

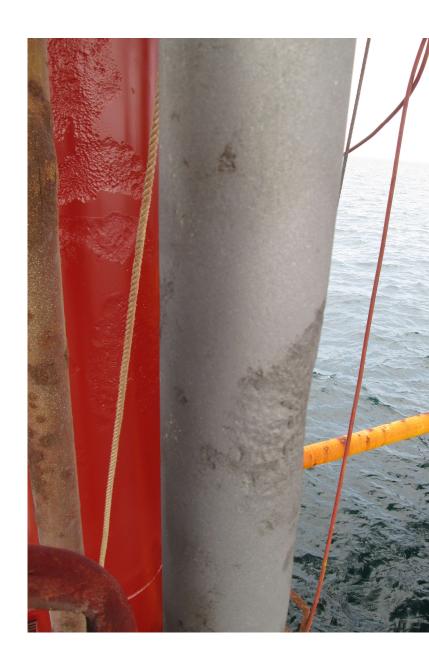
We know -

- Compressive strength
- Tensile strength
- Adhesive Strength etc.

However, not all applications are this straightforward, and will require more design input.

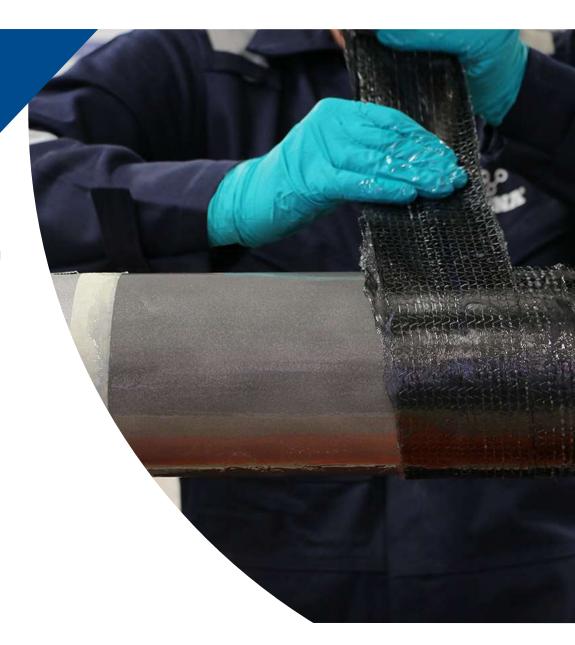
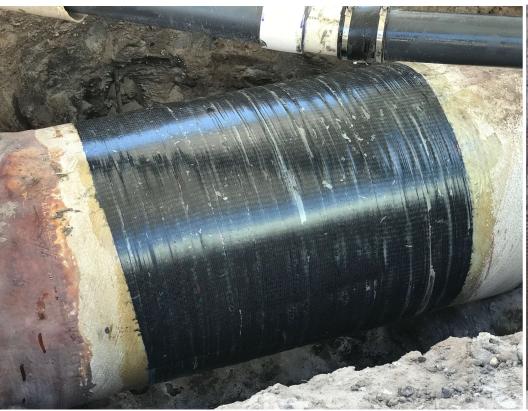
# Composite Repairs

Repair system fabricated of a thermoset resinused in conjunction with fiber reinforcement sheet.

This is designed in accordance with two standards:

ISO 24817 & ASME PCC-2

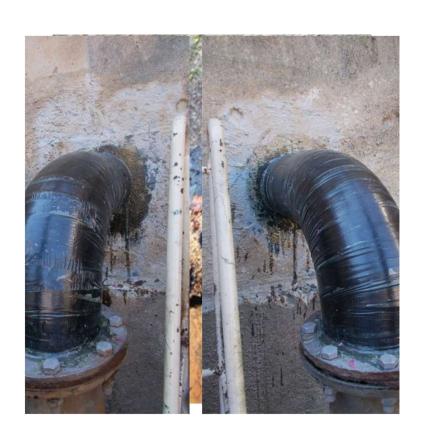
## Sample Design:

Design Temperature - 20°C
Design Pressure - 5 bar

Process Fluid - Cooling water

External Loads - None

Thickness - 6 mm
Axial Extent - 400 mm

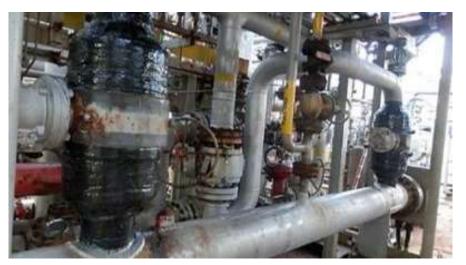
# Application of a composite wrap system

Corroded flange and fasteners on the high-pressure fuel gas heater inlet and outlet. The client could not afford for the flange or bolts to leak and be shutdown as this would become very costly. Protection of the system was required for 9 months until the next shutdown, where the entire unit would be replaced.

The application was carried out by validated Installers as per the method statement provided on the design. Following thorough surface preparation to the live system, an epoxy filler was applied to the flanges, bolts and pipe to create a smooth transition prior to application of the composite system.

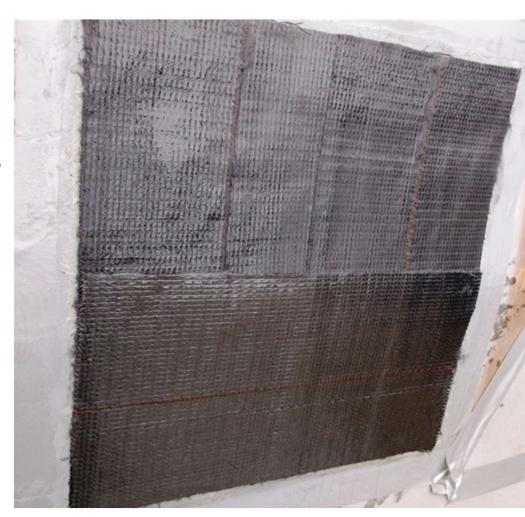
Corroded pipe requires reinforcement

- 2 vertical pipes (diameter: 1.1m)
- On ~ 70m inside a concrete pit (3.2m diameter)
- Bad ventilation system inside the pit → condensation in the bottom section → Corrosion

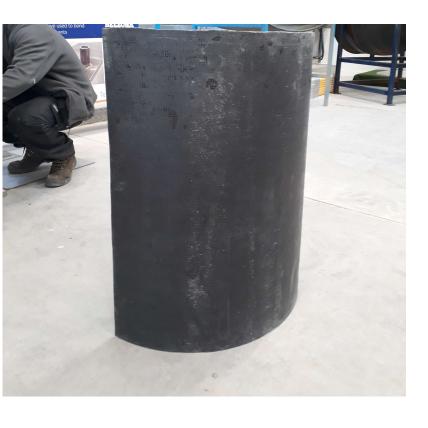
A composite patch was to be bonded in place on the external of the pipe.

This was to be completed using a pre-fabricated patch (500 x 500 mm), bonded with an epoxy.

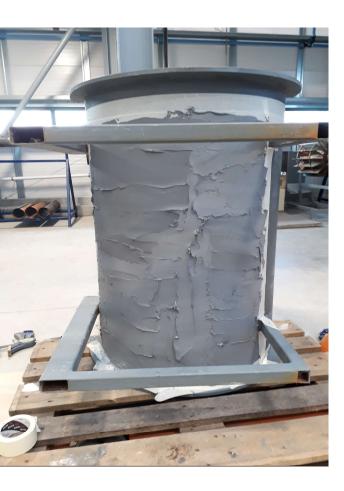
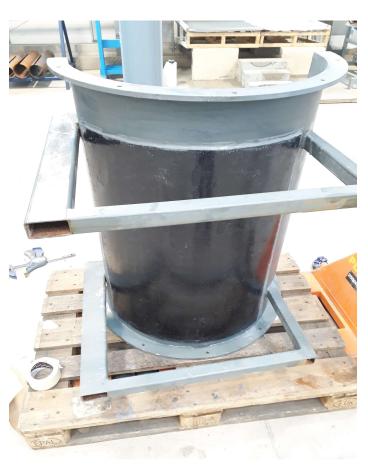
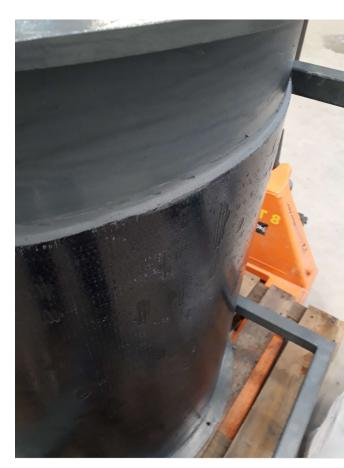
#### Workshop tests were completed:
