Listening for Corrosion – Using Acoustic Emission to Inspect Storage Tank Floors

Dr Ryan Marks CEng MIMechE

MISTRAS Group

TANKPAC – Tank Floor Inspection

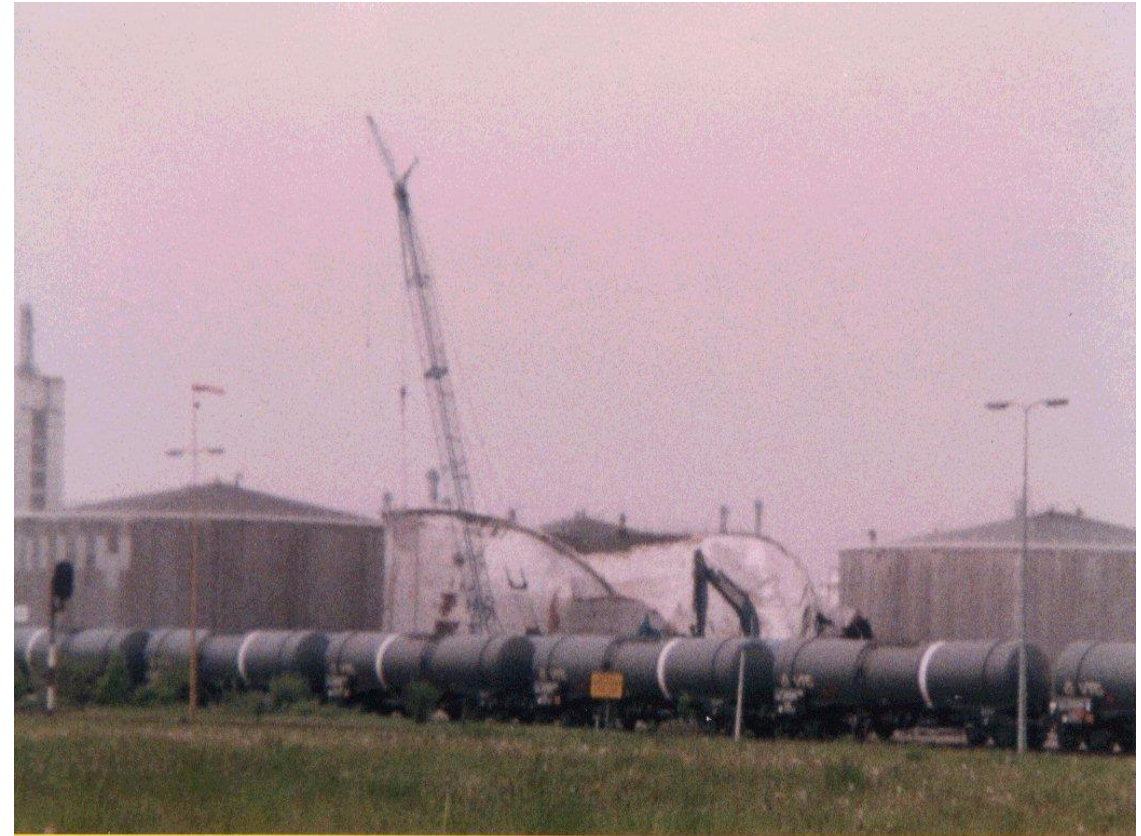
Case 1: HOT OIL TANK 140°C

Internally inspected 12 months prior to failure, including UT+MFL. This collapse was due to a narrow band of annular ring corrosion.

MFL could not get close enough to shell. In addition, the corrosion was so narrow, UT procedure could not detect its presence.

When the ring split the very rapid loss of hot liquid pulled a vacuum collapsing the tank shell.

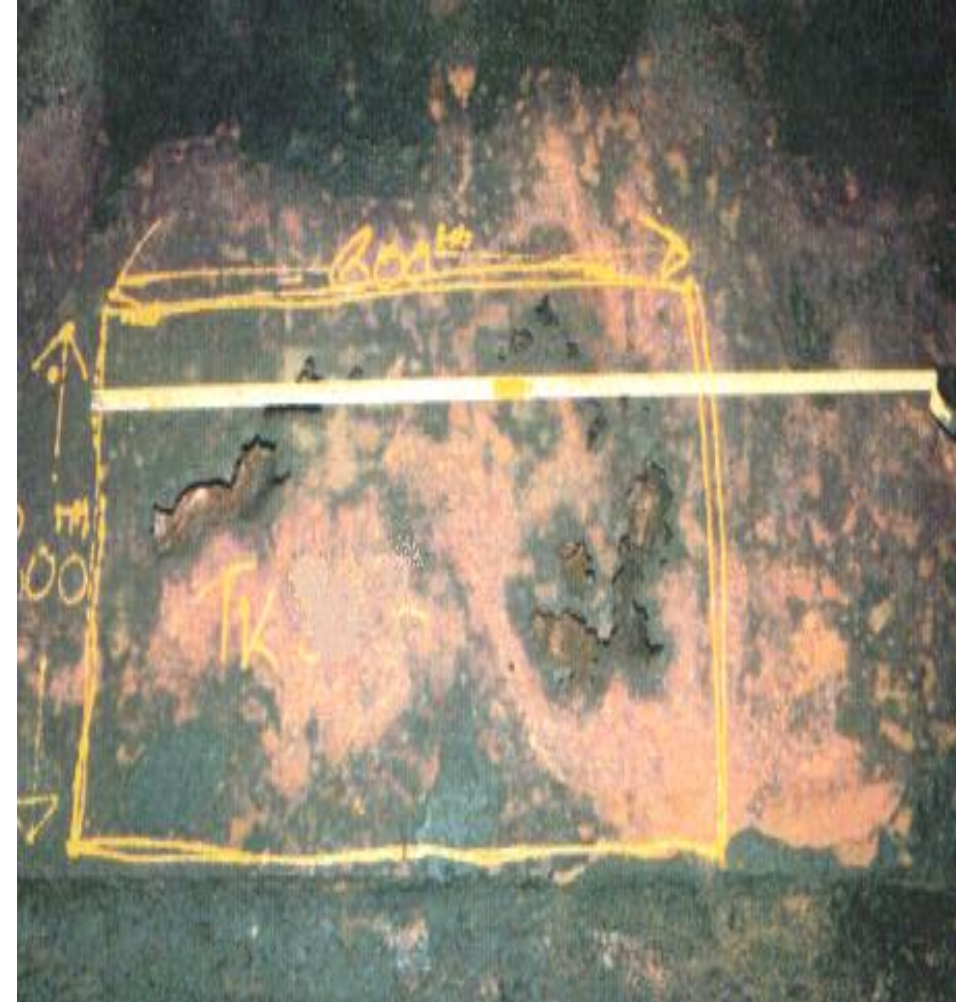
Case 2: 50m CRUDE OIL TANK

One of 40+ holes in the tank floor, although the tank was not leaking during service, only the sludge and debris were sealing the floor.

Attempts to re-suspend the sludge have resulted in major leakage on many occasions.

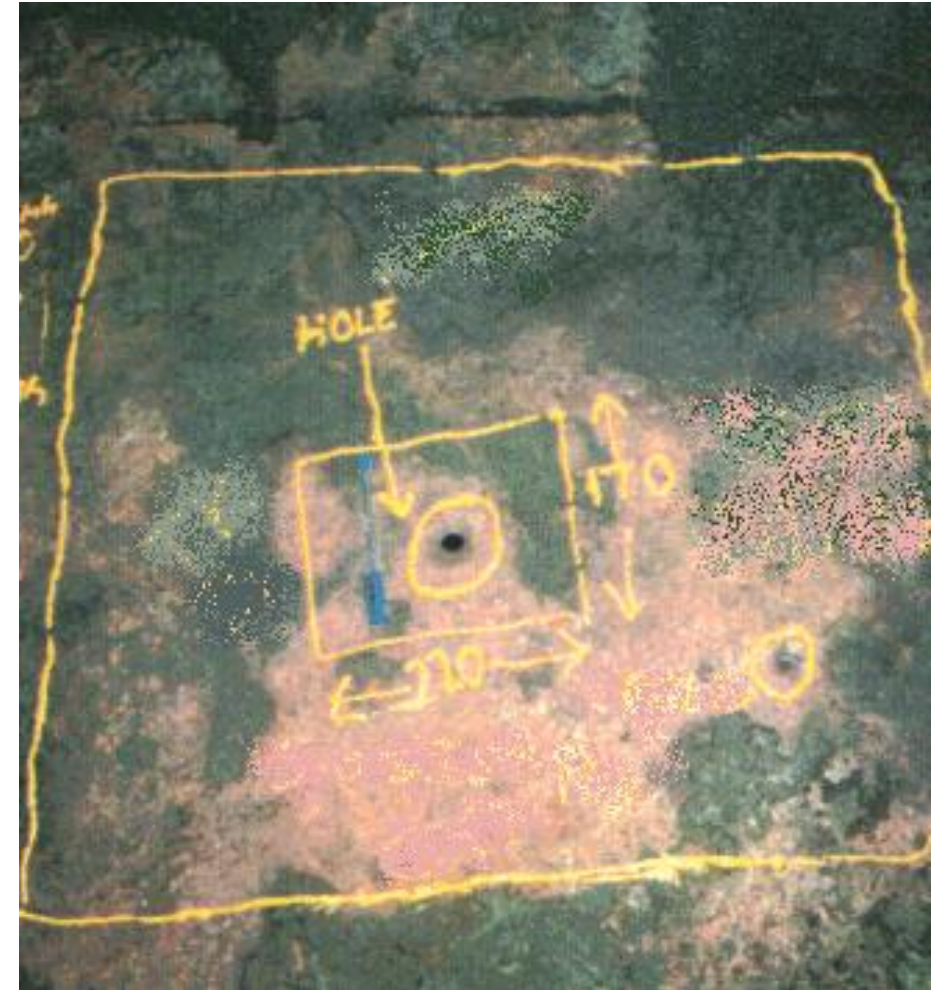
Case 3: NAPTHA TANK

Leaking 100 cubic metres per day through a 1cm hole.
Operations noticed losses after a week, but no visible product, which was disappearing into ground.
When the plates were cut the cavity under the floor was several cubic metres in size.

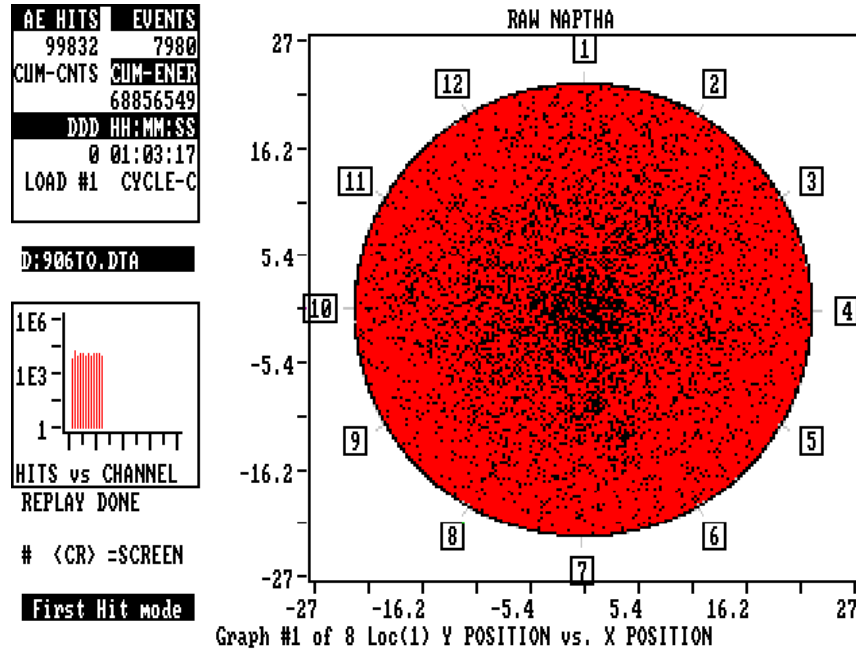
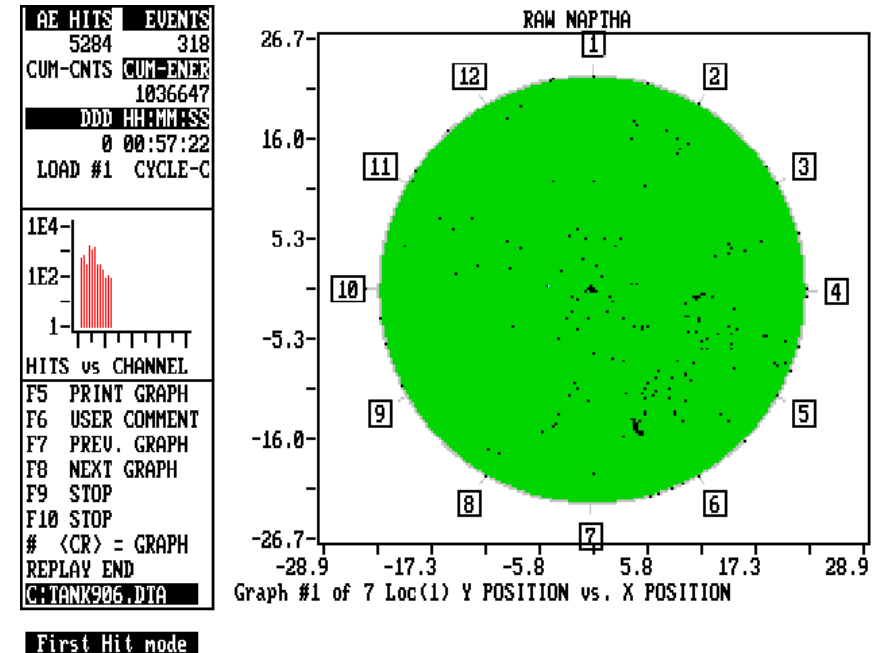
Naptha Tank: 'E' before repair; 'A' after Repair

GRADE **A** **B** **C** **D** **E**

" ALL DATA " TANK PLOT

OAL = 24%

OAL = 18.1%

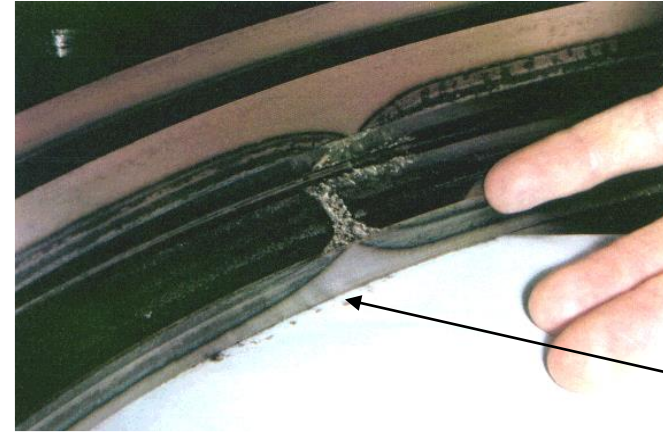
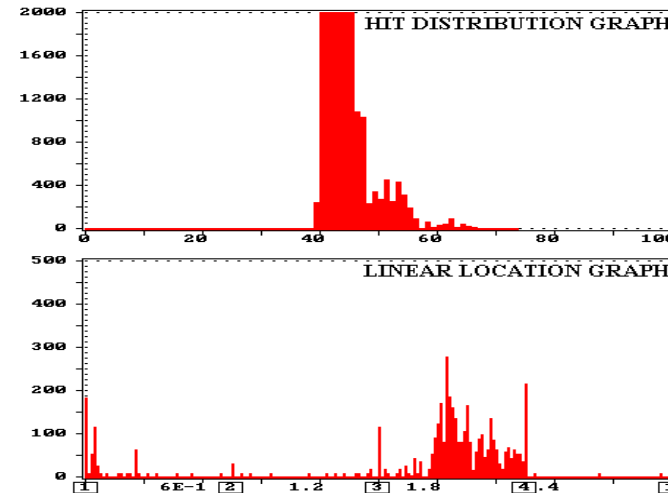
Location of damage around a 60 rpm radar bearing (3 sensors).

- Vibration signature difficult to identify due to low speed and high background noise.
- AE identifies:
 - Crushing of corrosion/debris.
 - Cracking and Fretting.
 - Lack of lubrication.
- Method:
 - Periodic AEM during normal operation.
 - AE classification of database.
 - Multiple sensors gives location.
 - Time series analysis gives fault diagnosis.

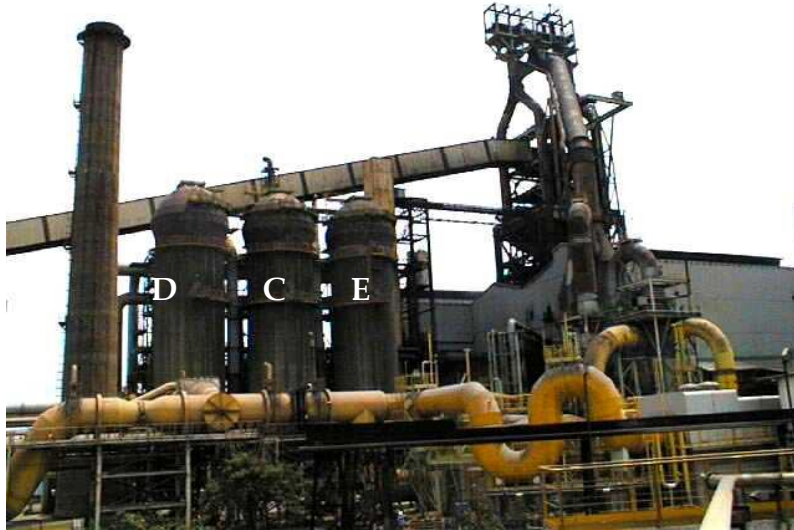
Acoustic Emission result on May 2001
Grade D, C and E as below

- Acoustic Emission monitoring carried out
- Three furnaces graded as follows;
C – Source found requiring further evaluation
D - Active sources requiring follow-up local inspection
E - Intense sources immediate action required
