SUSAN JACOB BEng. MSc

**UNIVERSITY OF ABERDEEN
DISSERTATION SUMMARY PRESENTATION**

**AN INVESTIGATION INTO THE
WRINKLING PHENOMENON ON CRA
LINED PIPELINES AND ITS IMPACT ON
PIPELINE INTEGRITY**

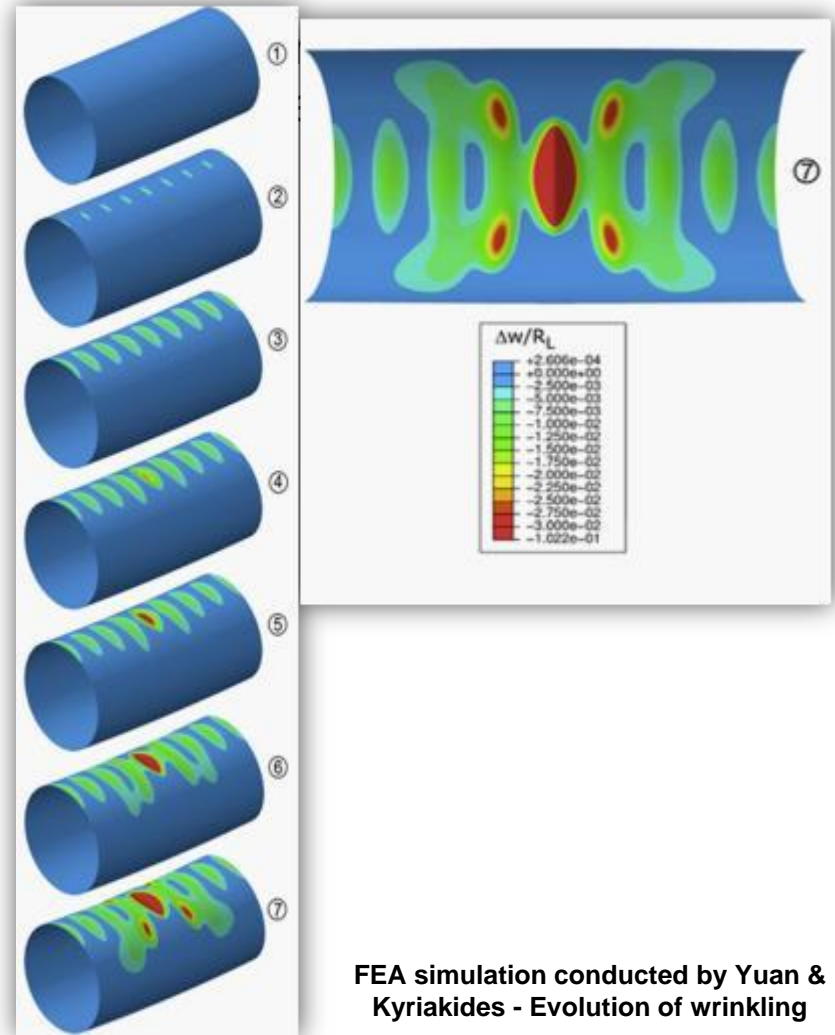
- Yuan and Kyriakides carried out FEA on the lifespan of a wrinkle leading to failure
 - **Image 1** – Ovalised pipe
 - **Images 2 & 3** – Periodic disturbances of small to medium amplitude wrinkles – also known as first stage of bifurcation
 - **Images 4 & 5** – Wrinkling localises at mid-span and a diamond buckling mode becomes apparent.
 - **Image 6** – Onset of second stage of bifurcation
 - **Image 7** – Butterfly shaped deformation with a major

FEA simulation conducted by Yuan & Kyriakides - Evolution of wrinkling

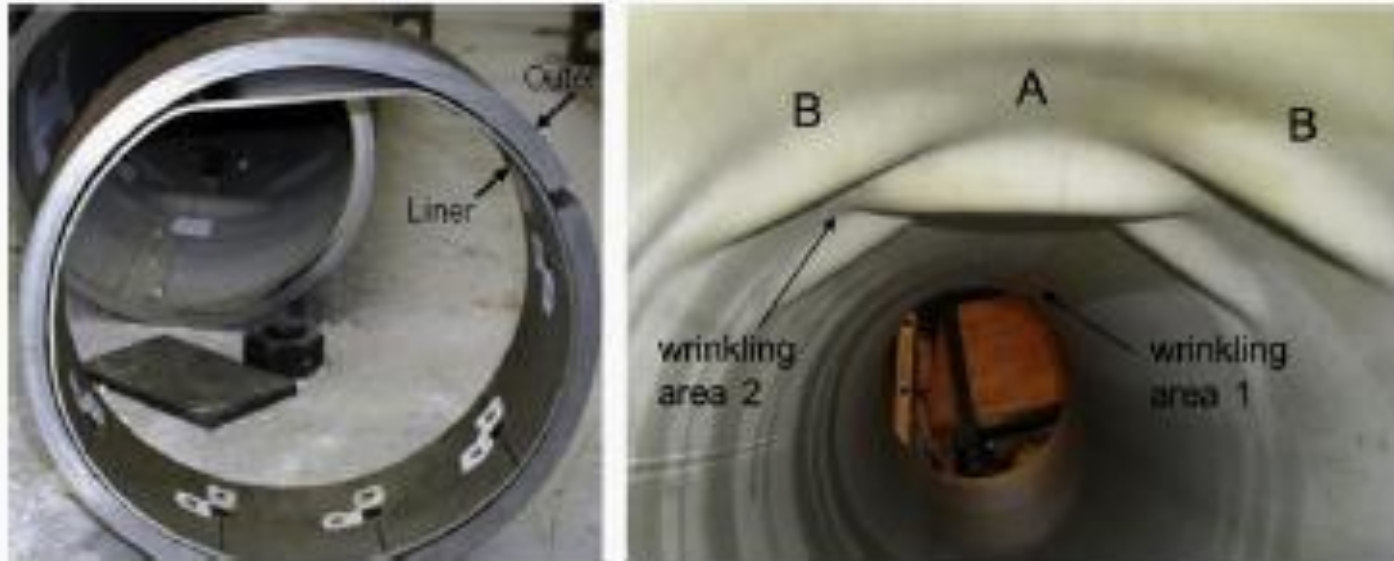
Fig. 1. Lined pipe, (a) photo after experimental testing (Focke, 2007) and (b) wrinkled liner pipe (Hilberink, 2011).

- Experimental observations (Focke, 2007) have indicated that the long lined pipe, after the occurrence of uniform wrinkling of the liner pipe (“wrinkling area 1 in Fig. 1b),
- Exhibits a second bifurcation in the form shown in “wrinkling area 2” of Fig. 1b. More specifically, one of the wrinkles grows rapidly,
- Forming one main buckle, symmetric about the plane of bending (denoted as (A) in Fig. 1b), and four minor buckles (denoted as (B) in Fig. 1b) from either side of the main buckle. The wavelength of the secondary buckling pattern is equal to twice the wavelength L_{hw} of the first buckling pattern.

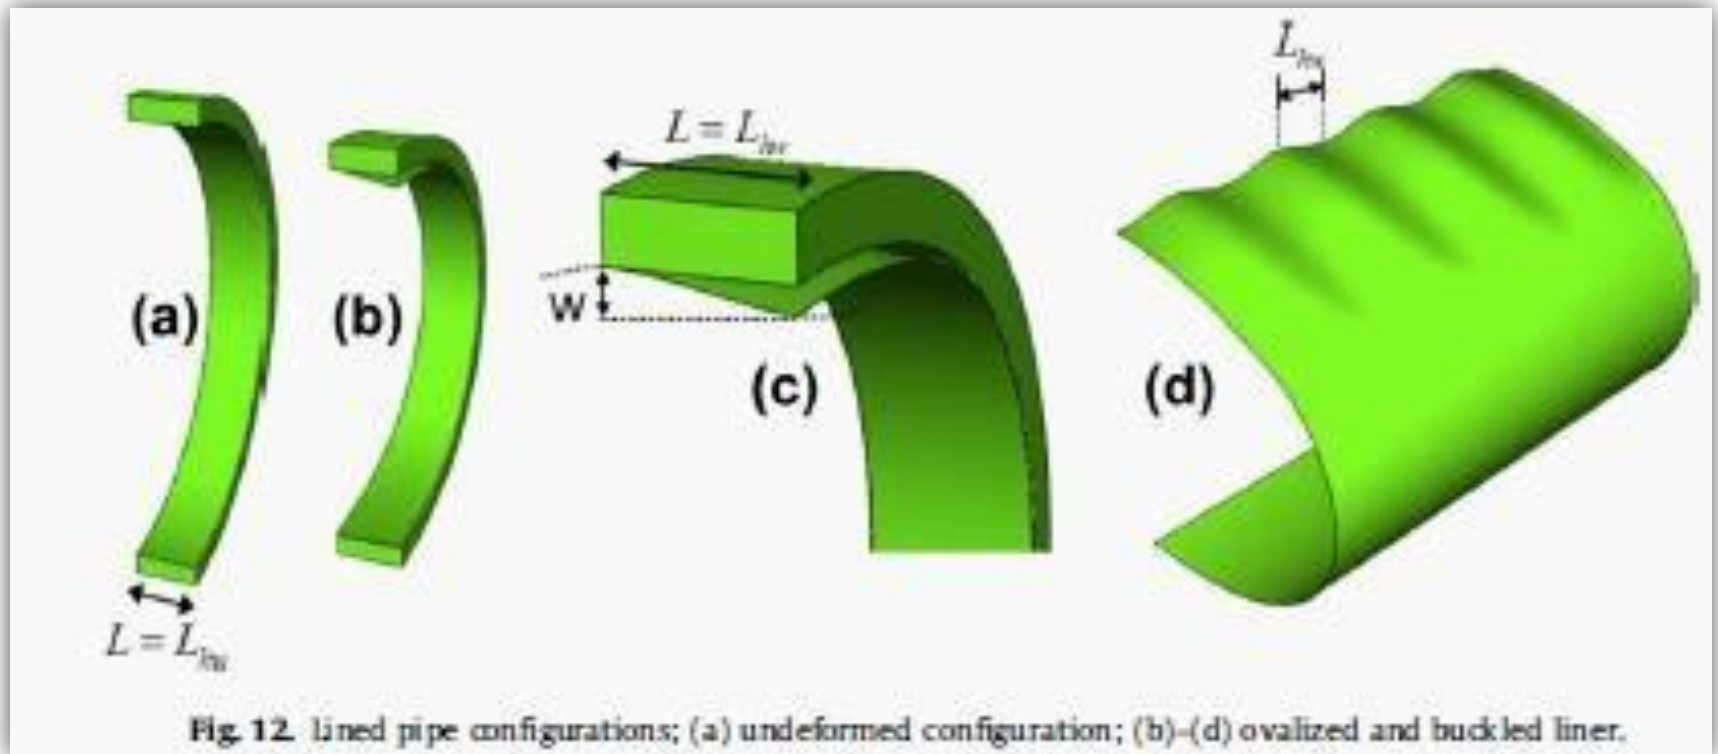
- The above figure gives an idea on the transition **from the ovalization to wrinkle formation**.
- Numerical analyses for calculating the wrinkle growth has compared well with the test measurements carried out (Mechanical behaviour of wrinkling of pipes).

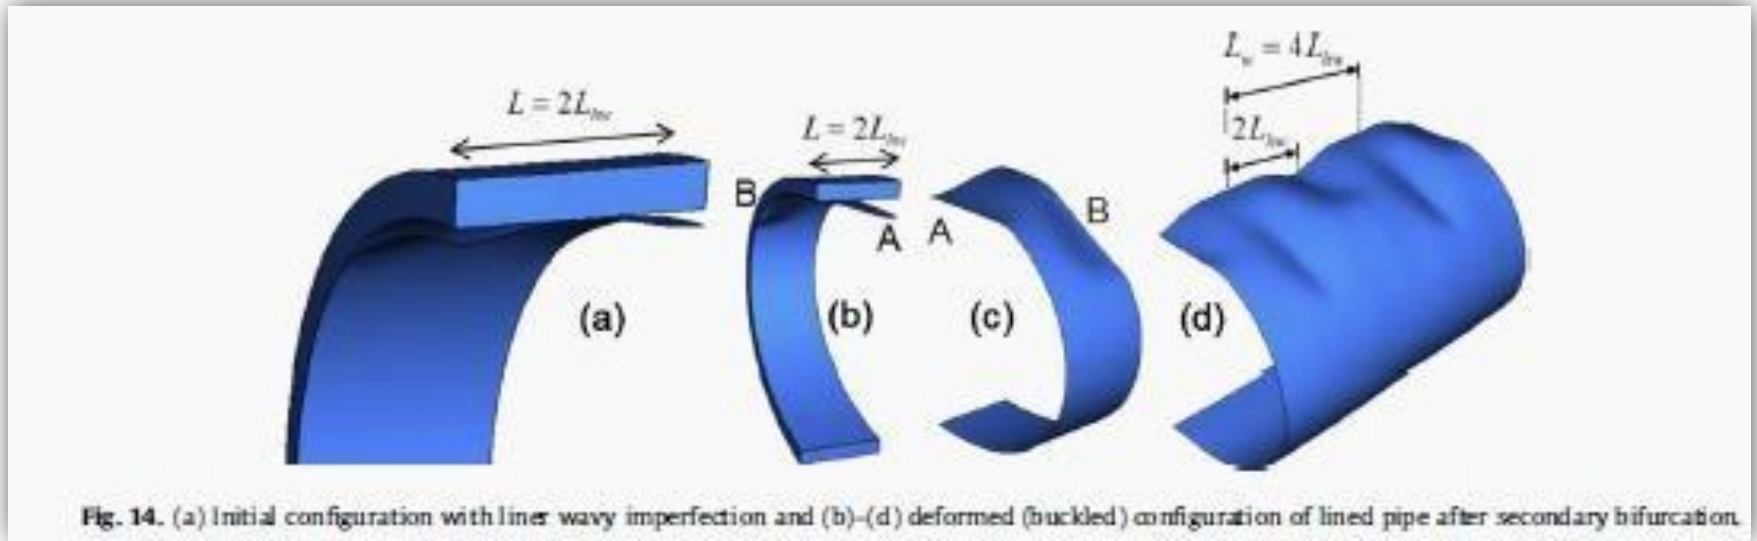
- Through experimental observations, it was noted that when the applied curvature reaches a certain value, the liner deformation bifurcates to the shapes shown
- In Fig. (b) and (c) above. Simulating the secondary buckling may not be possible as it is still under study.
