# Failure Analysis – An Insight Into Forensic Investigation, Failure Mechanisms & Prevention

26<sup>th</sup> November 2024

Sarah Bagnall

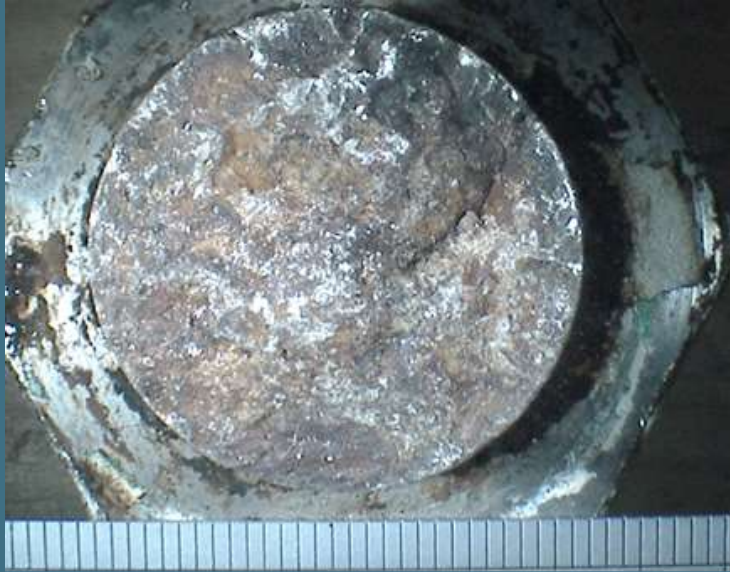
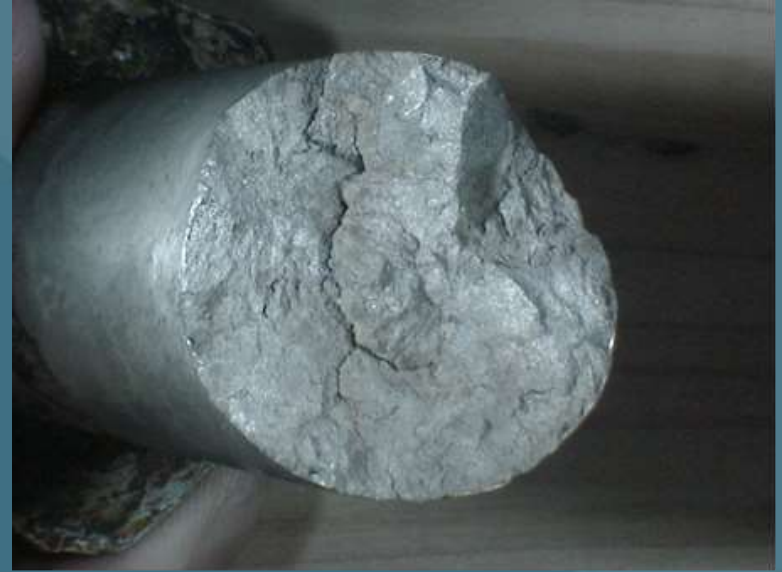
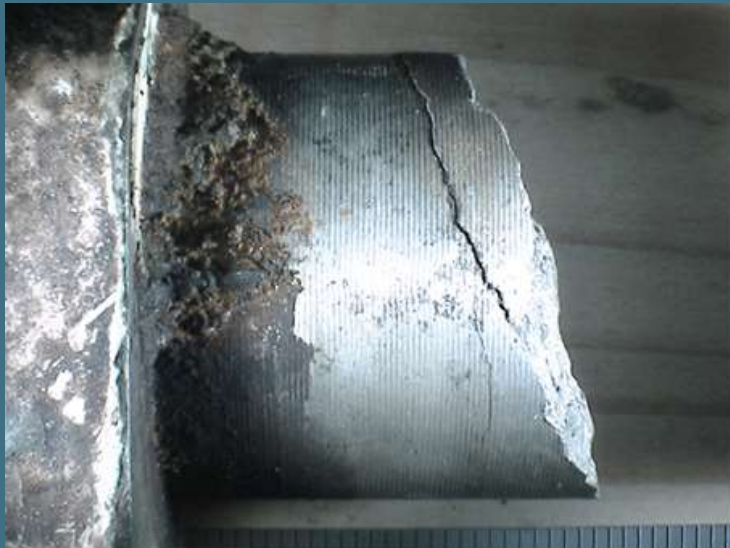
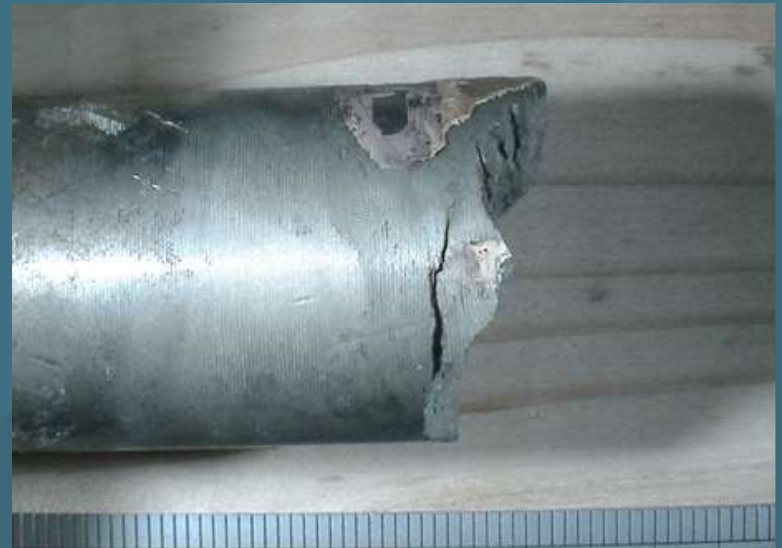
- Client experienced an oil leak from the main cargo line of an oil tanker used to transfer gas oil, gasoline, diesel and oil.
- The bolts used to secure the flange had fractured. The bolts had been in service for 6 months
- 304 stainless steel

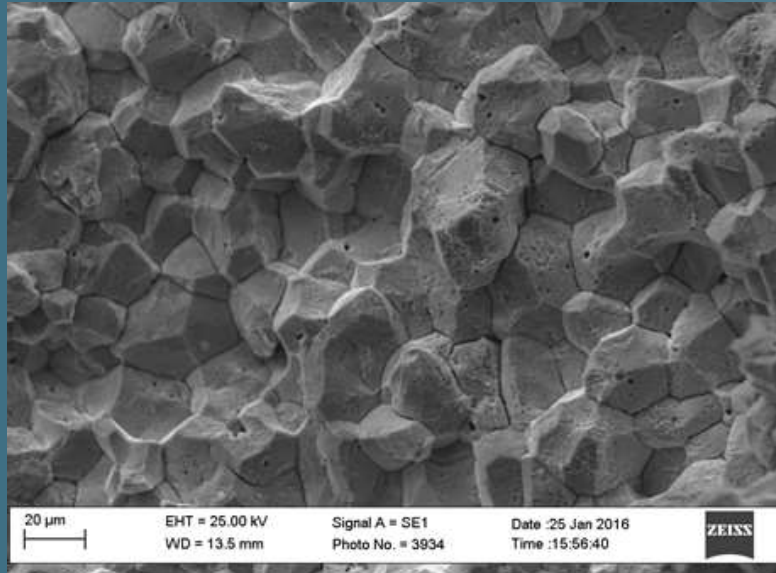
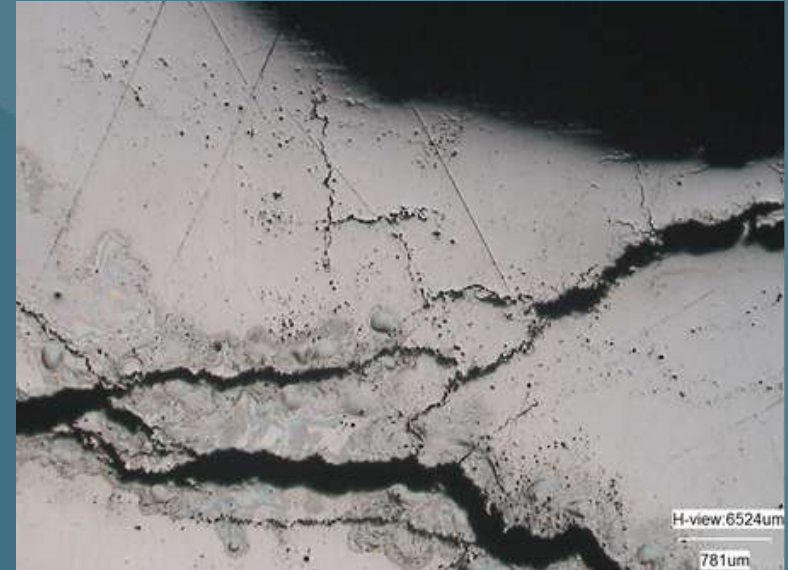
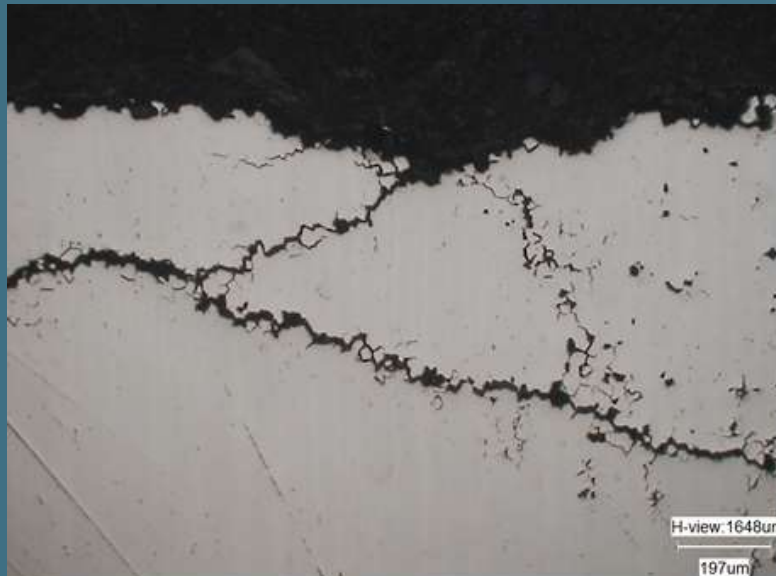
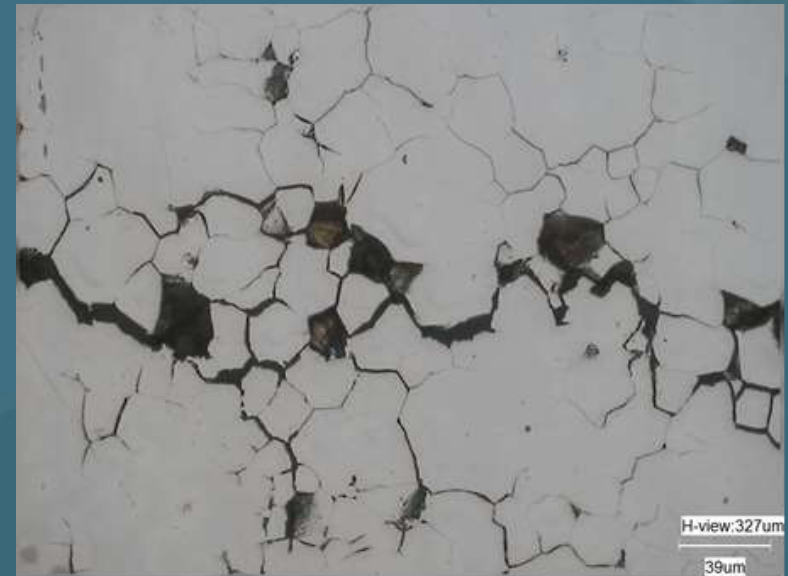
- Deposit contained significant levels of chlorine and sulphur.
- Microstructure was heavily sensitised

Mechanism was **Polythionic Acid Stress Corrosion Cracking**.

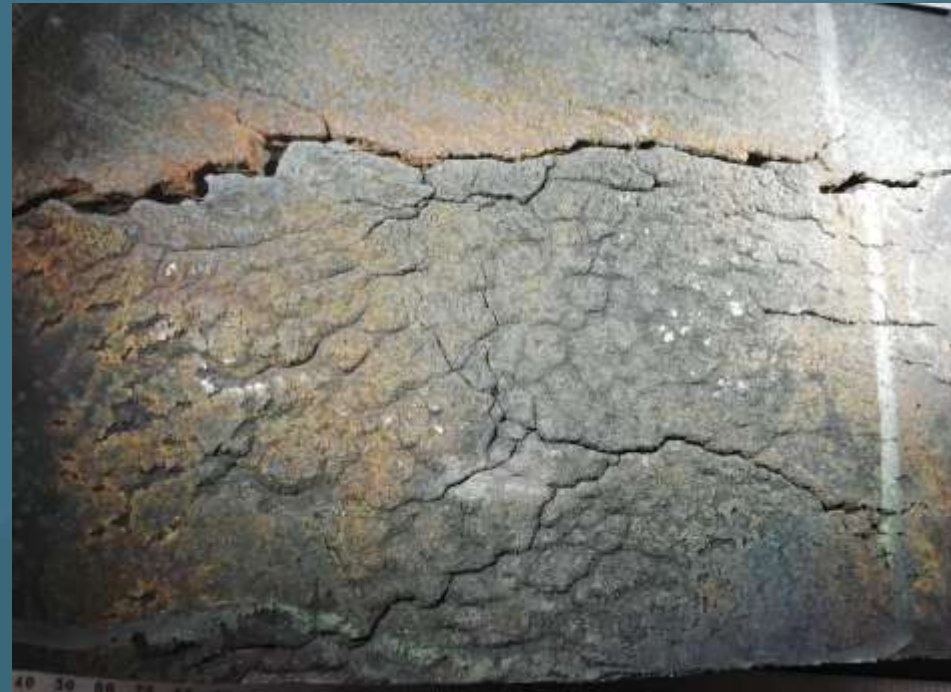
- Occurs due to the formation of sulphide scales in the presence of sulphur compounds, which then react with air and moisture during start-up/shutdown to form sulphur acids (polythionic acid).
- Sulphide is thought to have formed due to exposure to an environment containing hydrogen sulphide.
- In the presence of a tensile stress (residual or applied), polythionic acid attacks sensitised austenitic stainless steels adjacent to the chromium depleted grain boundaries, producing intergranular cracking.

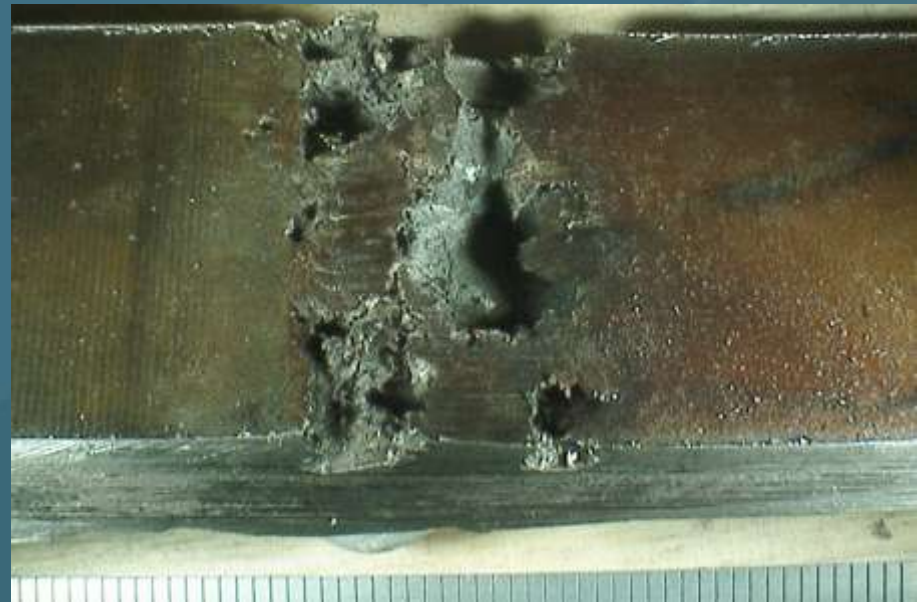
- Area of perforation evident within the weld
- At internal surface – significant metal loss was apparent below seemingly intact surface

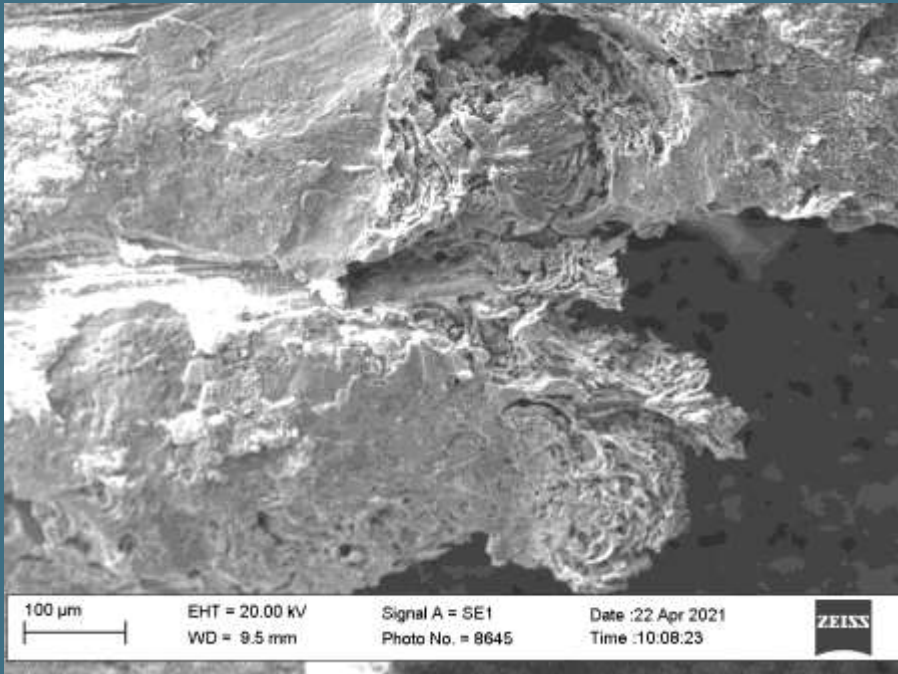
- SEM showed areas of selective attack in the vicinity of the hole
- Deposit contained significant levels of chlorine and sulphur

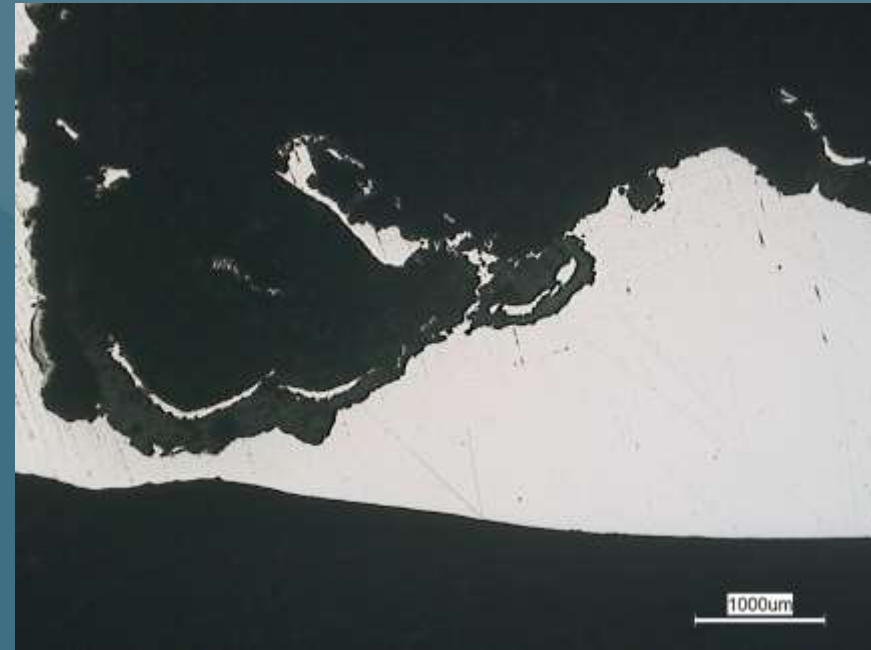
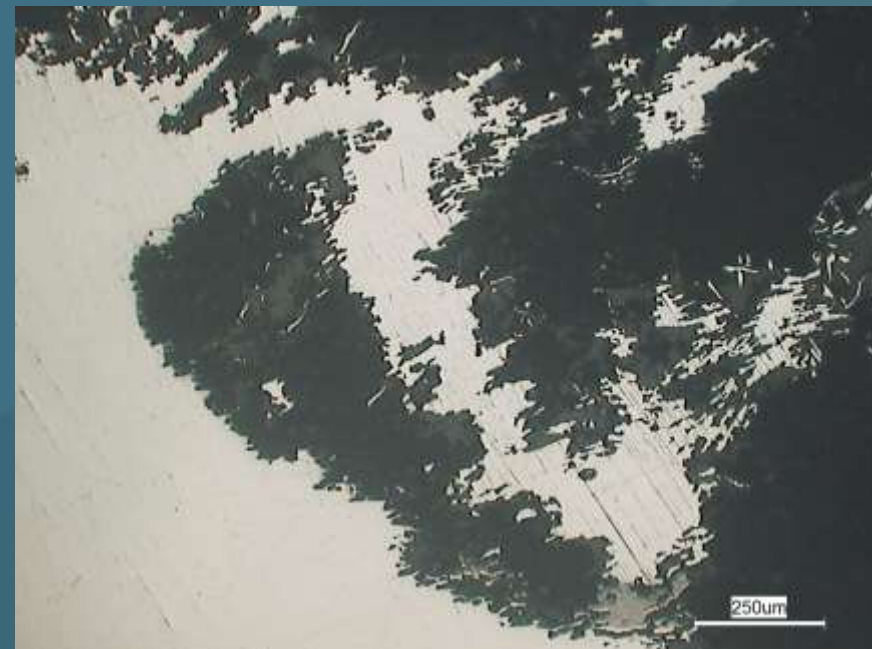
- Significant undercutting and hemispherical pitting evident within the weld metal

- Mechanism was deduced to be Microbial induced corrosion
- The presence of sulphur and the morphology of the pitting may indicate the presence of sulphate reducing bacteria. No sample was available to confirm this.
- The presence of carbides/nitrides along phase boundaries increases the likelihood of corrosion

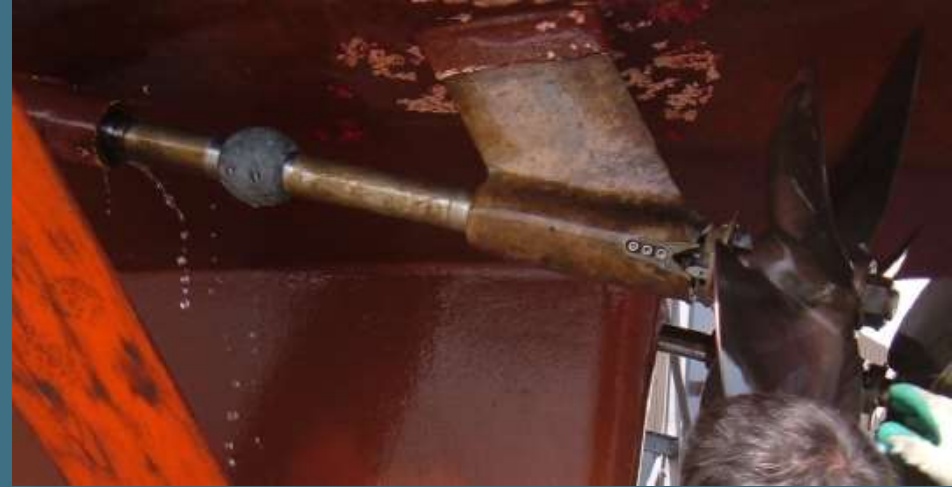
- Mechanism was deduced to be **Hydrogen Induced Stress Cracking (HISC)**
  - Hydrogen atoms form as a consequence of the cathodic protection.
  - Hydrogen atoms can either combine to form molecular hydrogen or become absorbed in the metal matrix.
  - For a susceptible material, this can lead to hydrogen cracking.
- The vessel adopted zinc anodes which were mounted directly on to the propeller shaft
- The vessel spent 80% of its time within freshwater and 20% at sea. Zinc anodes are typically employed for seawater environments, magnesium for freshwater.

- Review design of the CP system relative to the operating waters. Aluminium can be used in both seawater and freshwater.
- Ensure that the appropriate potential is used for the material grade.
- Inspection to be carried out periodically i.e. DPI

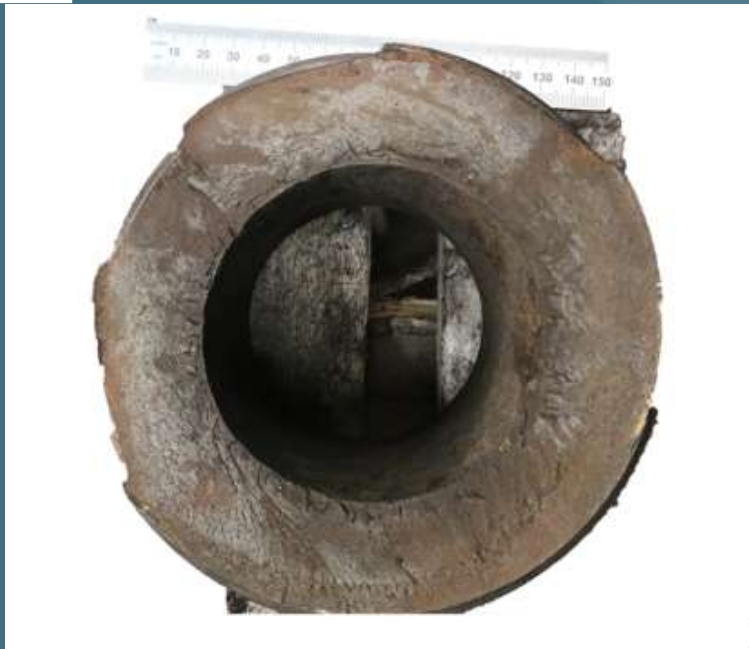
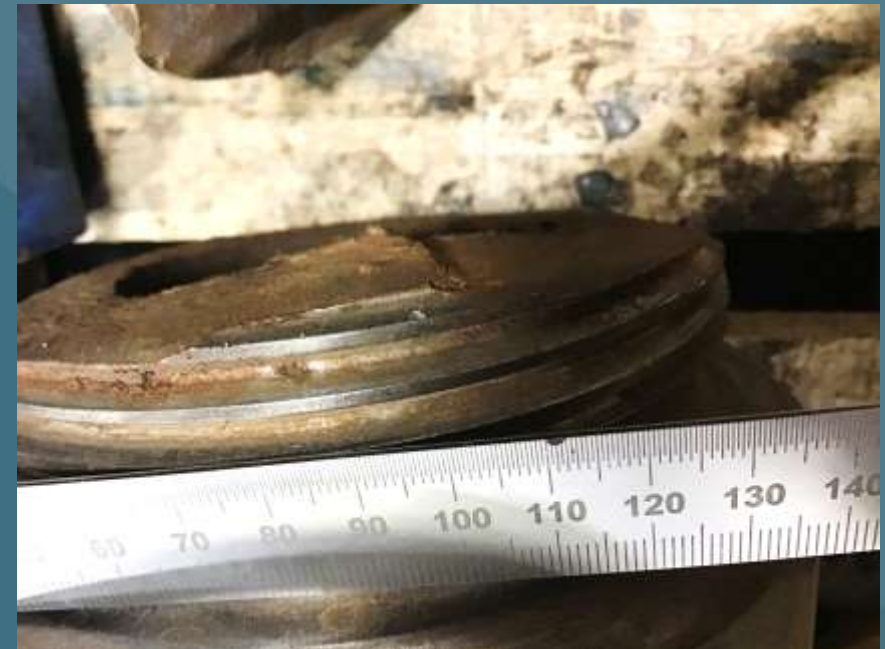
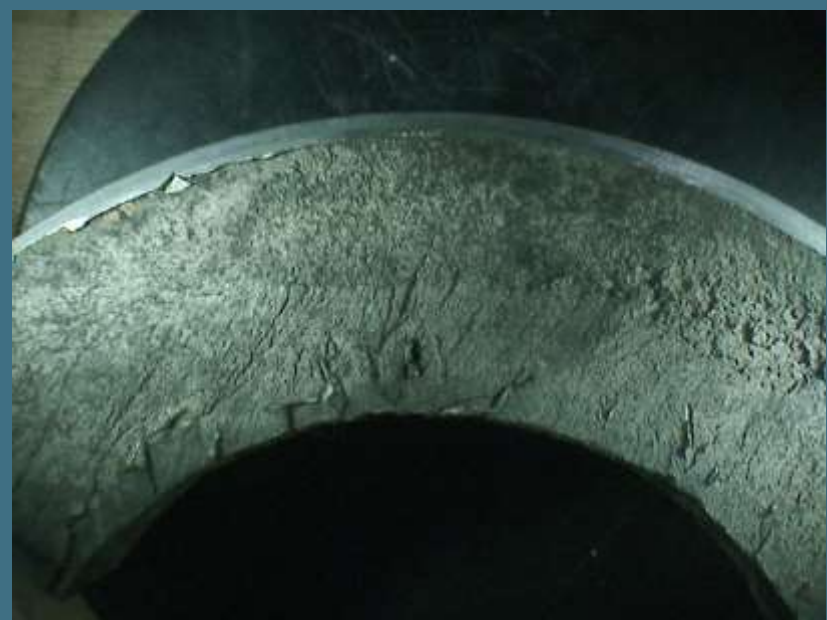
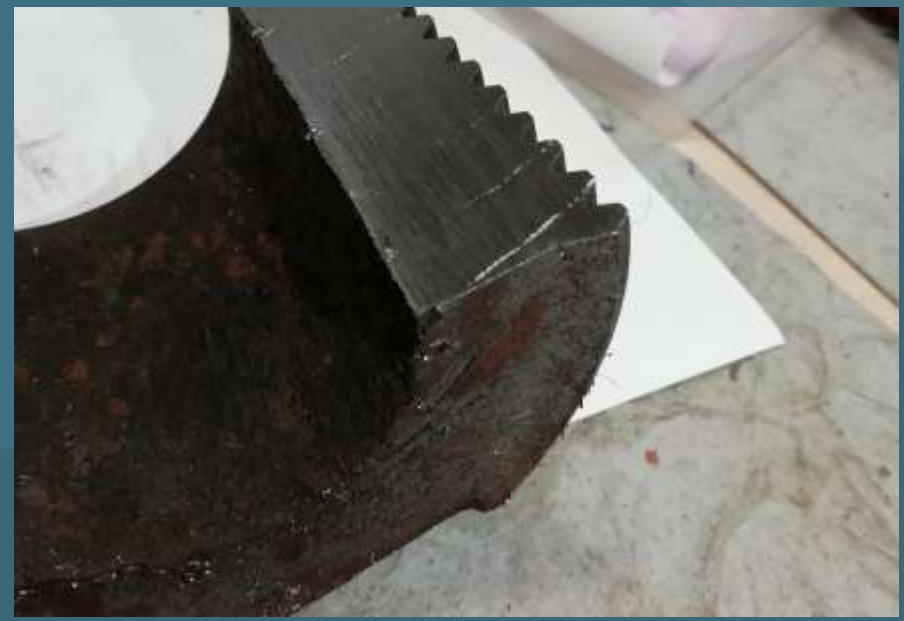
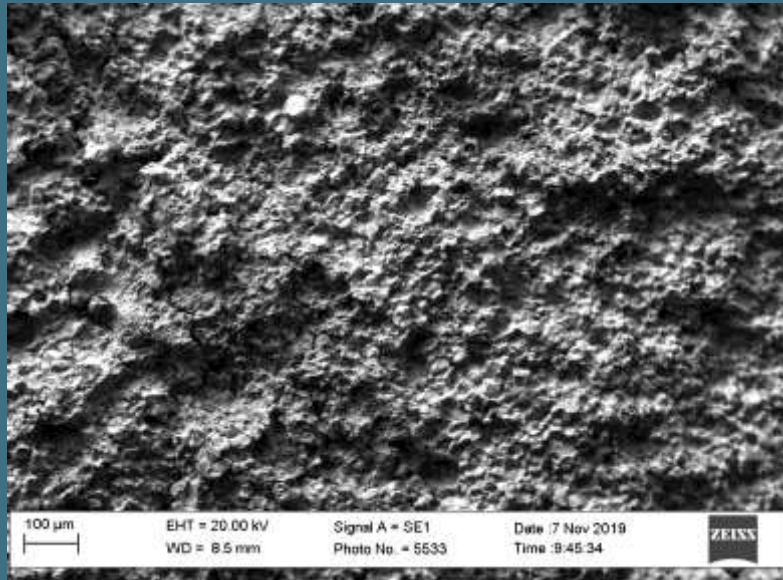
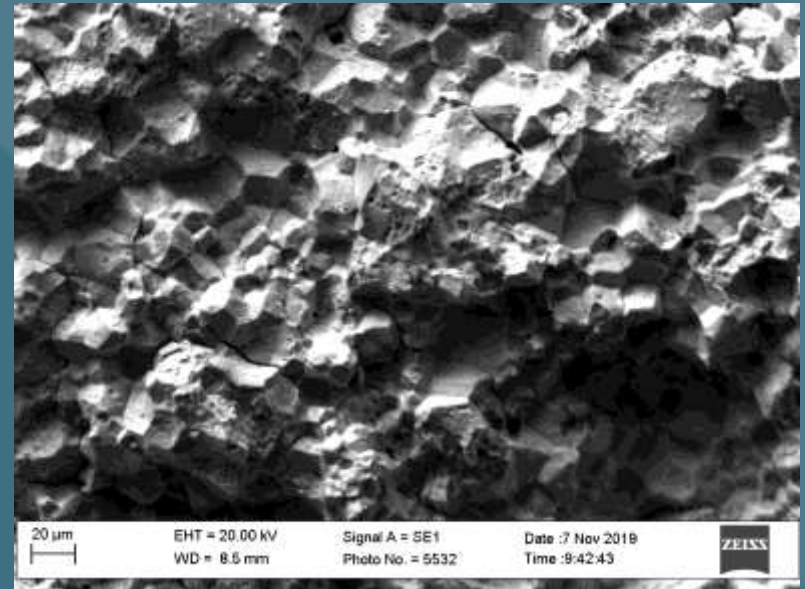
- Selective attack along internal surface
- Deposit contained significant levels of sulphur (up to 30%).
- Hardness levels were up to 520 Vickers. Material grade specifies a range of 302-362 Vickers. Light etching layer was 630 Vickers.

- Failure was attributable to sulphide stress corrosion cracking.
  - Occurs under the combined influence of a tensile stress and corrosion in the presence of water and hydrogen sulphide.
  - Tends to occur at temperatures below 82°C.
  - Susceptibility is primarily dictated by a material's hardness. 200 HV is generally used as the safe limit for carbon and low alloy steels.
  - The hardness levels for the pin were exceptionally higher than this level and the maximum specified for the material specification. Therefore, the pin would be considered highly susceptible to sulphide stress corrosion cracking.

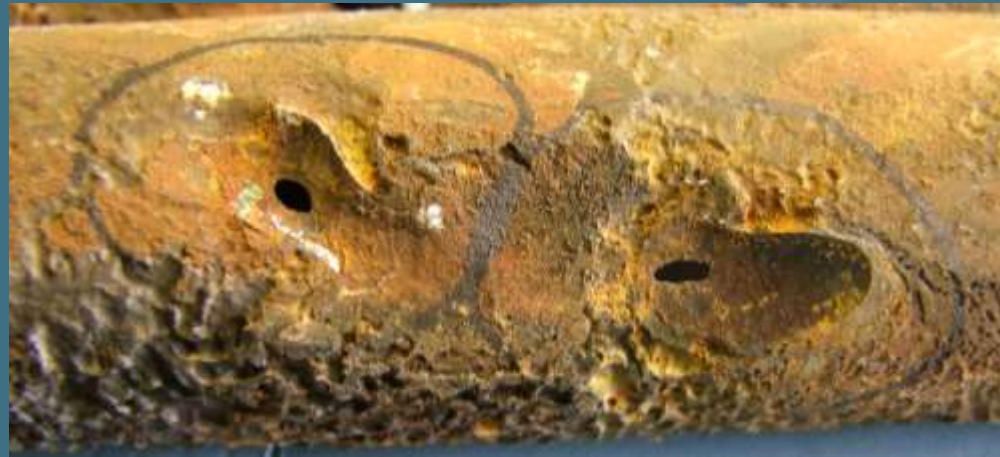
- Mechanism was identified as **Sulphuric Acid Dewpoint Corrosion**:
  - Occurs when metal temperatures fall below the sulphuric acid dew point of the flue gas. Generally termed “cold-end corrosion” since it generally affects the cooler regions.
  - Sulphur is present in heavy oil and during combustion, sulphur oxides are generated, a small portion of which becomes  $\text{SO}_3$ .
    - As the exhaust gas temperature reaches the dew point or lower, vapour-phase sulphuric acid forms.
    - If this contacts the lower-temperature metal surface it can condense as liquid sulphuric acid, attacking the underlying metal.
  - Temperature at which sulphuric acid condenses varies between  $116 - 166^\circ\text{C}$  or higher
    - Depends on the  $\text{SO}_3$  and water vapour concentrations in the exhaust gas.
    - The dew point increases with  $\text{SO}_3$  content and moisture content.

- Controlling corrosive quantities of sulphur trioxide in the flue gas
  - Operate the boiler at or below 5% excess air to the burners
  - Minimise air infiltration
  - Specify fuels with low sulphur content
- Controlling the level of moisture in the flue gas
  - Specify fuel with low moisture content
  - Prevent tube leaks
  - Reduce amount of soot blowing

- Controlling metal surface temperatures
  - Requires substantial design changes
- Feeding of fuel additives and/or cold end additives i.e. MgO
- Periodic removal of ash deposits
- Application of a corrosion inhibitor following cleaning and drying during shutdown. Humidity control can also be implemented.
- Weathering steels, such as COR-TEN and S-TEN, have been reported to be highly resistant to sulphuric acid dew point corrosion in comparison to low carbon steels and the majority of stainless steels.
