CORROSION UNDER INSULATION

René Goderie

December 2024

A VERY SIGNIFICANT "NEAR MISS"

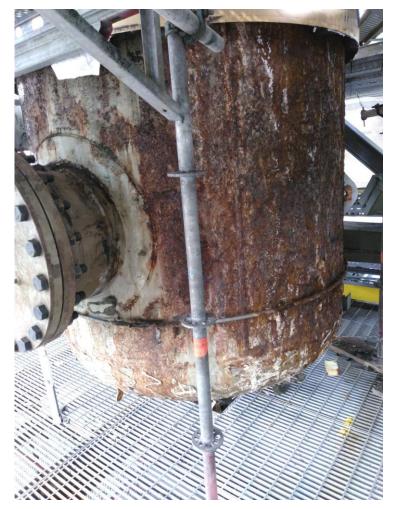
CUI Examples

- CUI is a significant problem for industry.
- For process plant, most common external damage mechanism.
- Primarily associated with carbon steel and stainless-steel components.
- Poses a major safety risk if left unchecked.
- Corrosion is hidden, often localised and rate can be unpredictable.
- Substantial cost to business and industry to address and manage this damage mechanism.
 - Safety and reputation
 - Financial impact
 - Unplanned events/ repairs
